**PIC16F/LF1938/1939
Silicon Errata and Data Sheet Clarification**

The PIC16F/LF1938/1939 family devices that you have received conform functionally to the current Device Data Sheet (DS41364D), except for the anomalies described in this document.

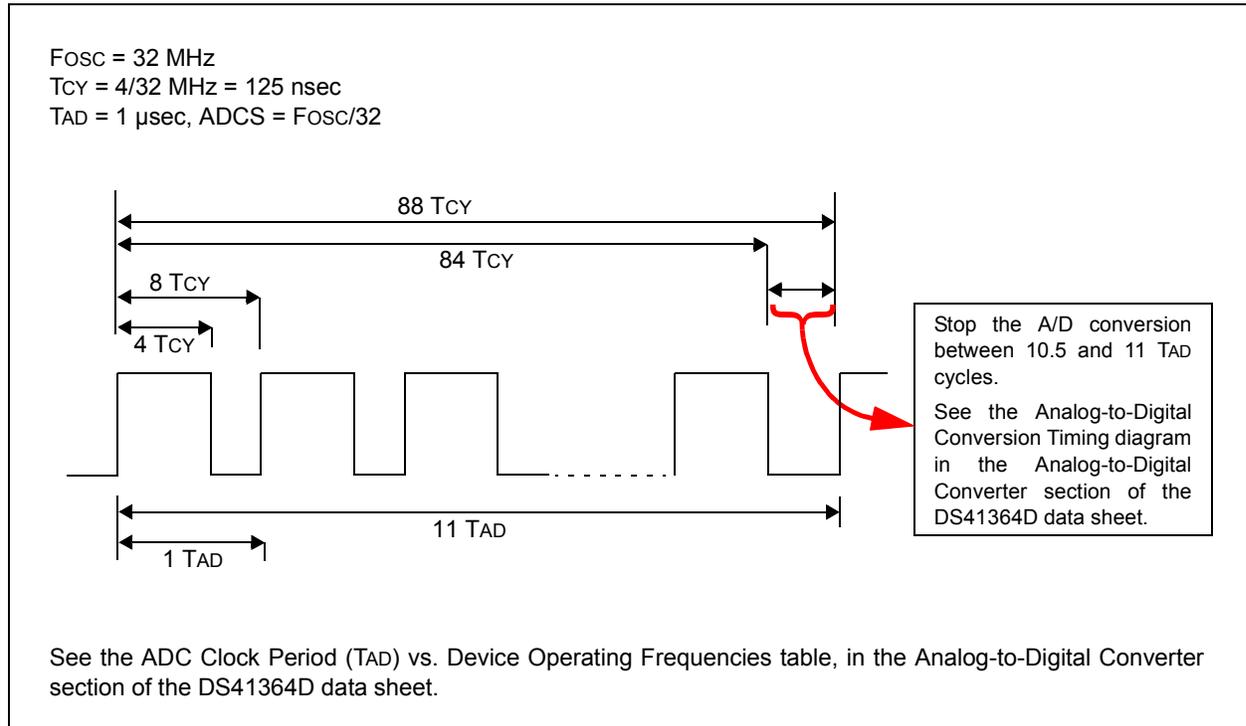
FIGURE 1: INSTRUCTION CYCLE DELAY CALCULATION EXAMPLE

Under certain device operating conditions, the ADC conversion may not complete properly. When this occurs, the ADC Interrupt Flag (ADIF) does not get set, the GO/DONE bit does not get cleared and the conversion result does not get loaded into the ADRESH and ADRESL result registers.

In Figure 1, 88 instruction cycles (Tcy) will be required to complete the full conversion. Each TAD cycle consists of 8 Tcy periods. A fixed delay is provided to stop the A/D conversion after 86 instruction cycles and terminate the conversion at the correct time as shown in the figure above.

Note: The exact delay time will depend on the choice of FOSC and the TAD divisor (ADCS) selection. The TCY counts shown in the timing diagram above apply to this example only. Refer to Table 3 for the required delay counts for other configurations.

Method 2: Provide a fixed delay in software to stop the A-to-D conversion manually, after all 10 bits are converted, but before the conversion would complete automatically. The conversion is stopped by clearing the GO/DONE bit in software. The GO/DONE bit must be cleared during the last 1/2 TAD cycle, before the conversion would have completed automatically. Refer to Figure 1 for details.

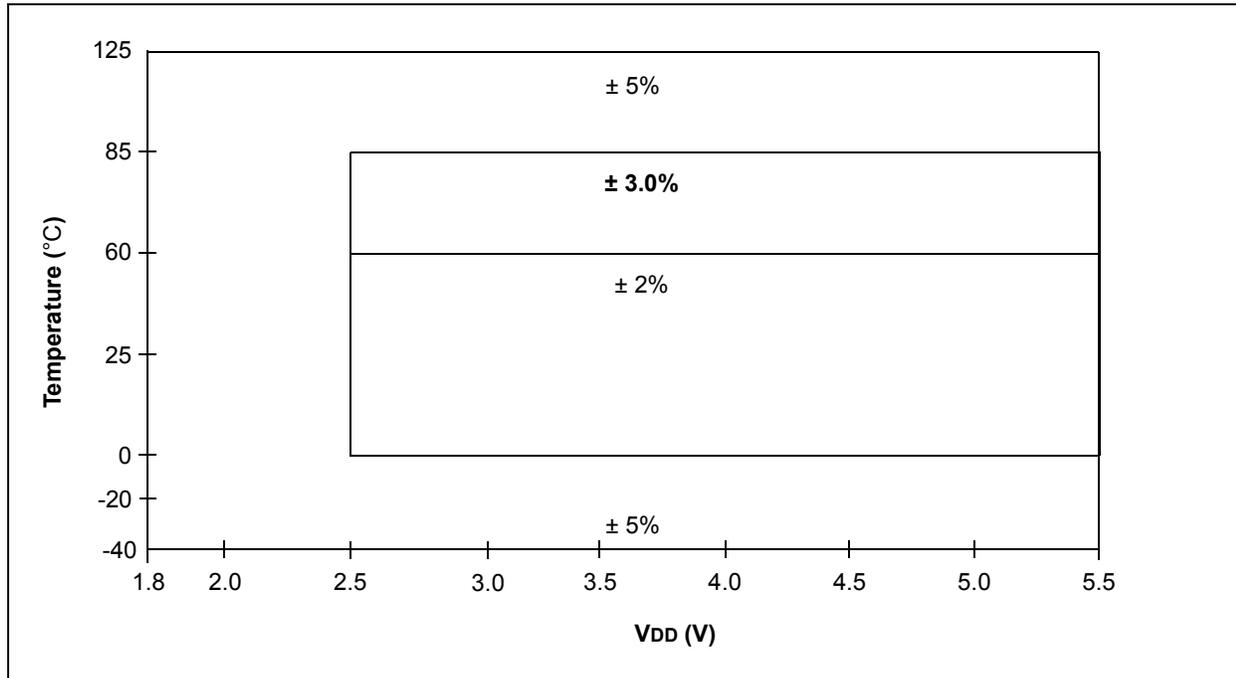
FIGURE 29-3: HFINTOSC FREQUENCY ACCURACY OVER DEVICE V_{DD} AND TEMPERATURE

In Figure 29-3, HFINTOSC Frequency Accuracy Over Device V_{DD} and Temperature, the oscillator accuracy should be $\pm 3.0\%$ when V_{DD} is equal to and above 2.5V and when temperatures are equal to and above 60°C, yet still equal to or below 85°C, as shown below.
