Radiometry as a Tool:

Trouble-shooting Production Problems in a Kitchen Cabinet Manufacturing Plant

By Karin Efsen and
Jim Raymond

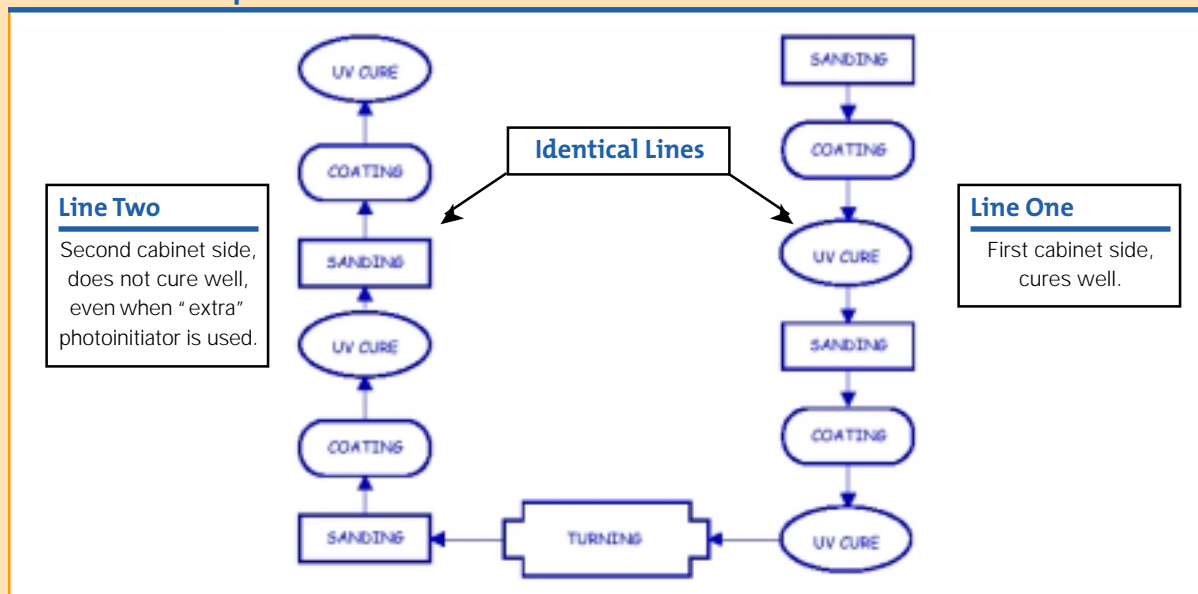
FIGURE 1

Two “identical” production lines

The manufacturing plant used one production line to sand, coat and cure one side of the door, and the second production line replicated the process on the other side of the door. The results were not the same, and there was no obvious reason for the difference. The manufacturer consistently achieved good results on the first side of the cabinet door, but the topcoat on the second side did not cure well. The manufacturer resorted to adding extra photoinitiator to the coating used on the second side of the door, and still did not achieve results as good as those seen on the first side.

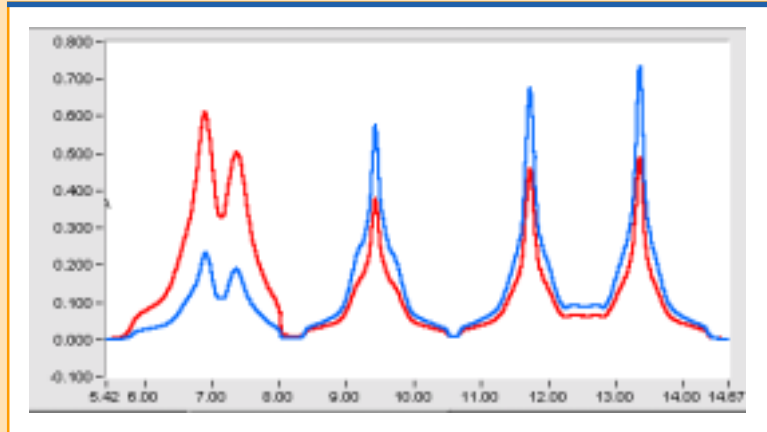
FIGURE 2

Measurement of line one: 8:40 a.m.

Line one is the side of the line that was producing good-quality cabinet doors. It consisted of four UV systems. The first system contained a mercury-gallium additive bulb that was set up out of focus. The mercury-gallium

bulb was identified by the high UVV to UVA ratio and confirmed by the plant staff. Because the system was running out of focus, the profile showed the double peaks for the first lamp. Three focused mercury bulbs followed the first UV system.

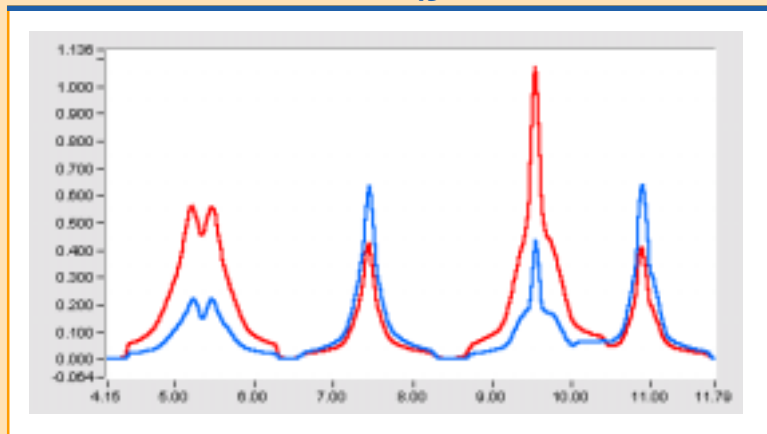
FIGURE 3

Measurement of line two: 8:43 a.m.

Line two was the side of line that was not producing good-quality cabinet doors. It consisted of four UV systems. The first UV system contained a mercury-gallium additive bulb that was set up out of focus. Instead of being followed by three focused mercury bulbs, line two was followed by a mercury bulb, then a mercury gallium bulb and then a mercury bulb.

By looking at the irradiance profiles, the first major conclusion was discovered about five minutes after starting the trouble-shooting process—a different bulb was being used in the third UV station in line two.

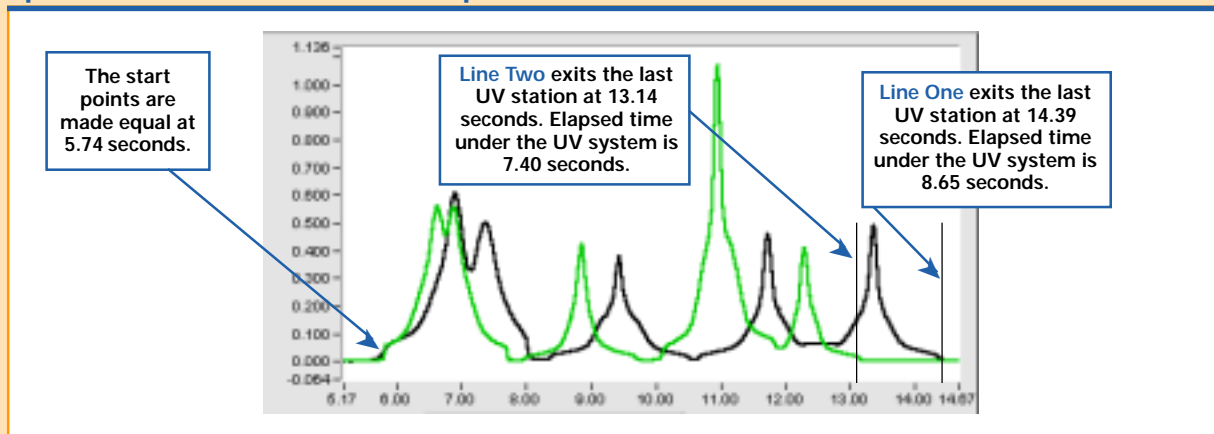
FIGURE 4

The computer software with the profiling radiometer allows two files to be viewed at the same time. It also allows the files to be synchronized and placed on top of each other. When this is done, it leads to another very important observation about the two production lines. In Figure 4, only the UVV profiles are shown for clarity. Line one (good curing) is shown in black and line two (poor curing) is shown in green. It takes the radiometer longer to pass through line one than it does to pass through line two. There is an absolute difference of 1.25 seconds or 14.5%. On radiometers that report only numbers, the difference in the speeds of the two production

Speed measurement of the two production lines

By looking at the irradiance profiles, the second major conclusion was discovered about 20 minutes after starting the trouble-shooting process—line two is running approximately 14% faster than line one.

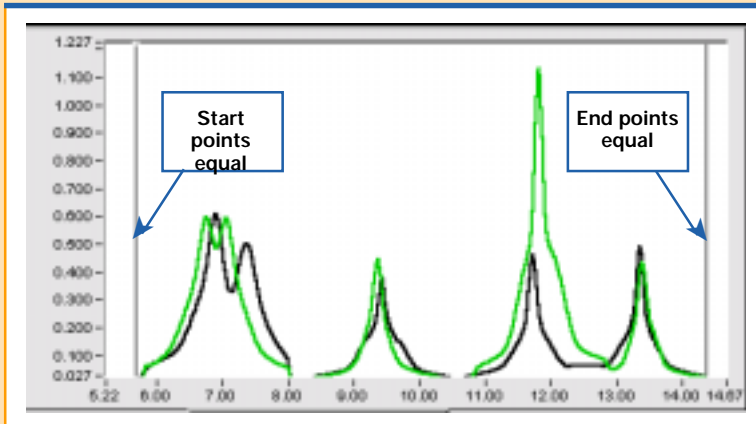
FIGURE 5

Adjustment of the process speed on line two and measurement again: 9:00 a.m.

With the change and equalization in speed on line two, there was a closing of the gap in the number of joules. For a true comparison and equalization between line one and line two, the third bulb in line two needed to be changed to a mercury bulb instead of a mercury-gallium bulb.

Adjustments were made to the speed on line two until it was similar to the speed of line one. The results are displayed in Figure 5. Again, only the UVV profiles are shown for clarity. Line one (good curing) is shown in black and line two (poor curing) is shown in green.

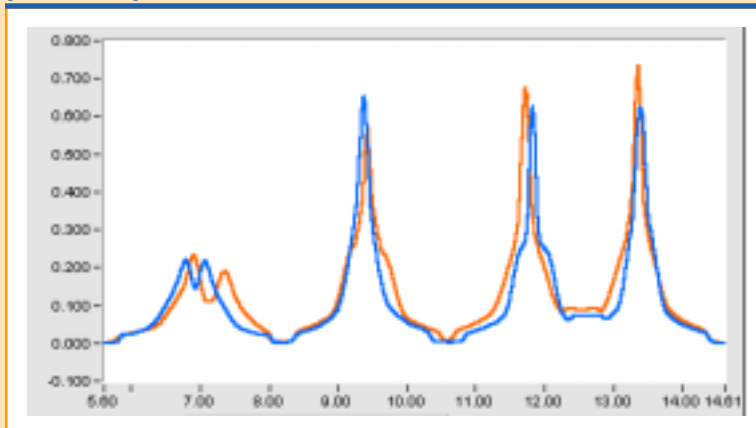
FIGURE 6

When both the speed and third bulb in line two were changed, the traces matched up much better. Figure 6 (on previous page) compares UVA with line one in orange and line two in blue.

Comparison of line one and line two (UVA)—changing of the bulb and measurement at the same process speed of the line: 9:48 a.m.

Line two was shut down, allowed to cool, and the third bulb was changed to a mercury bulb. The system was restarted and allowed to warm up.

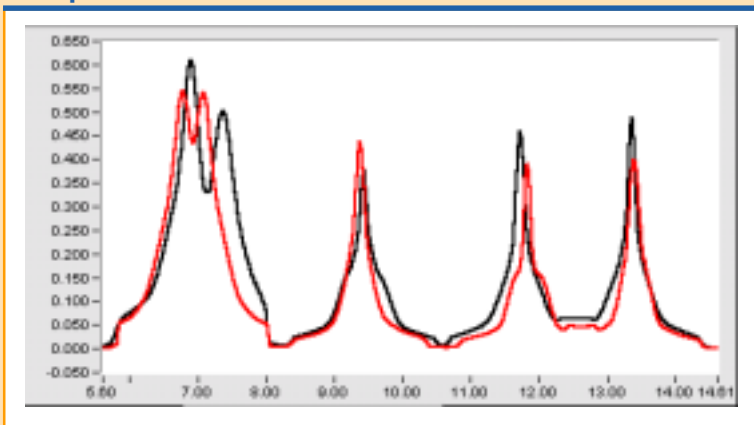
FIGURE 7

Figure 7 compares UVV with line one in black and line two in red.

Comparison of UVV
