# Condenser Tubes in Thermal Power Plants Issues and Solutions

ICCI 2014  
April 24, 2014

Presented by Dan Janikowski  
+1 262 642 8365  
E-Mail: [djanikowski@plymouth.com](mailto:djanikowski@plymouth.com)

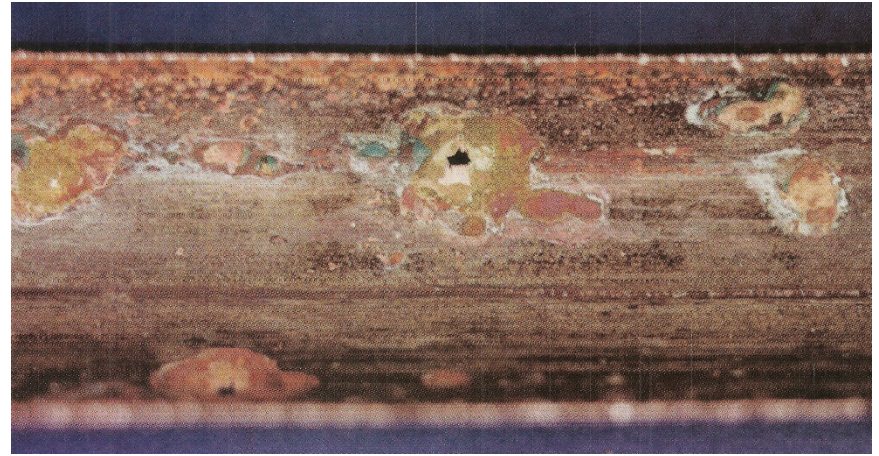
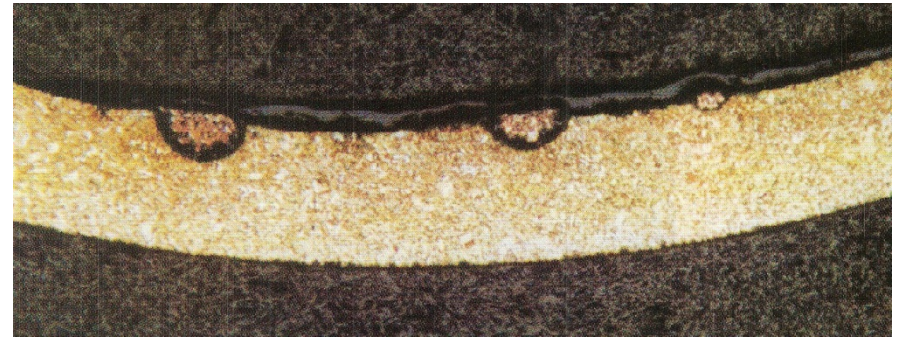
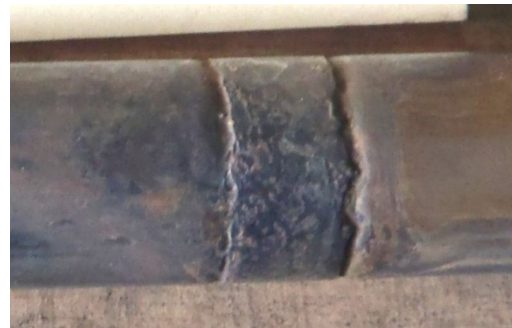
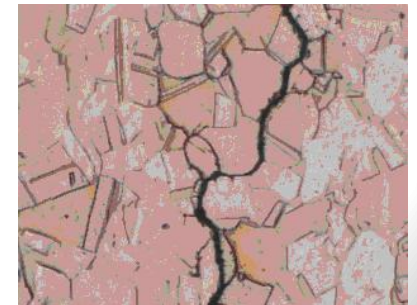
- Pitting and crevice corrosion
- Dealloying
- Ammonia Grooving & SCC

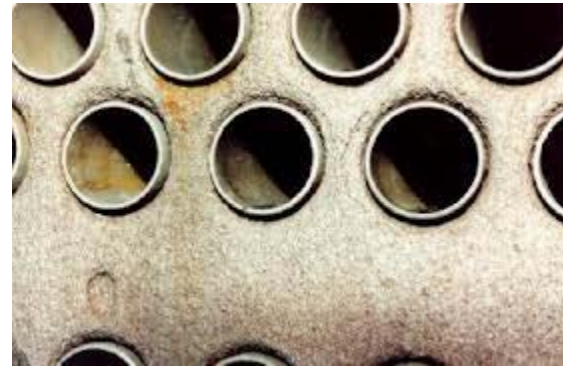
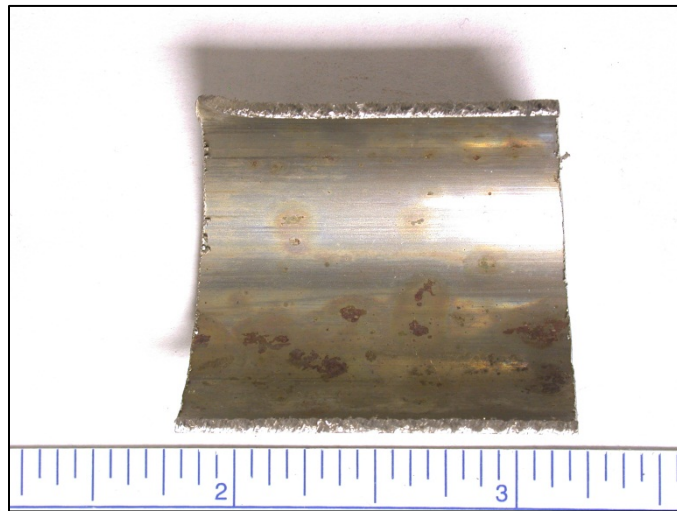
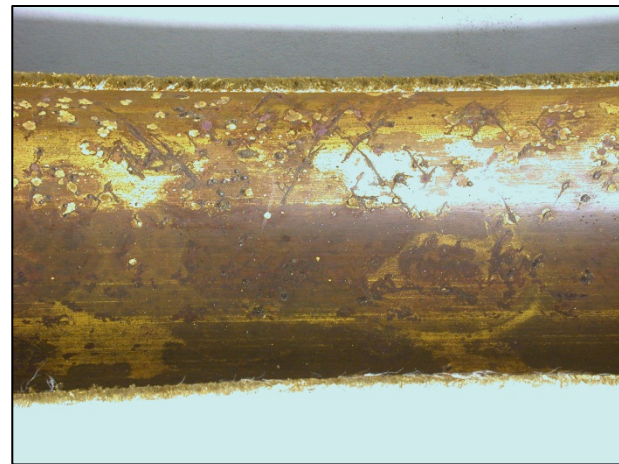
- Galvanic Corrosion

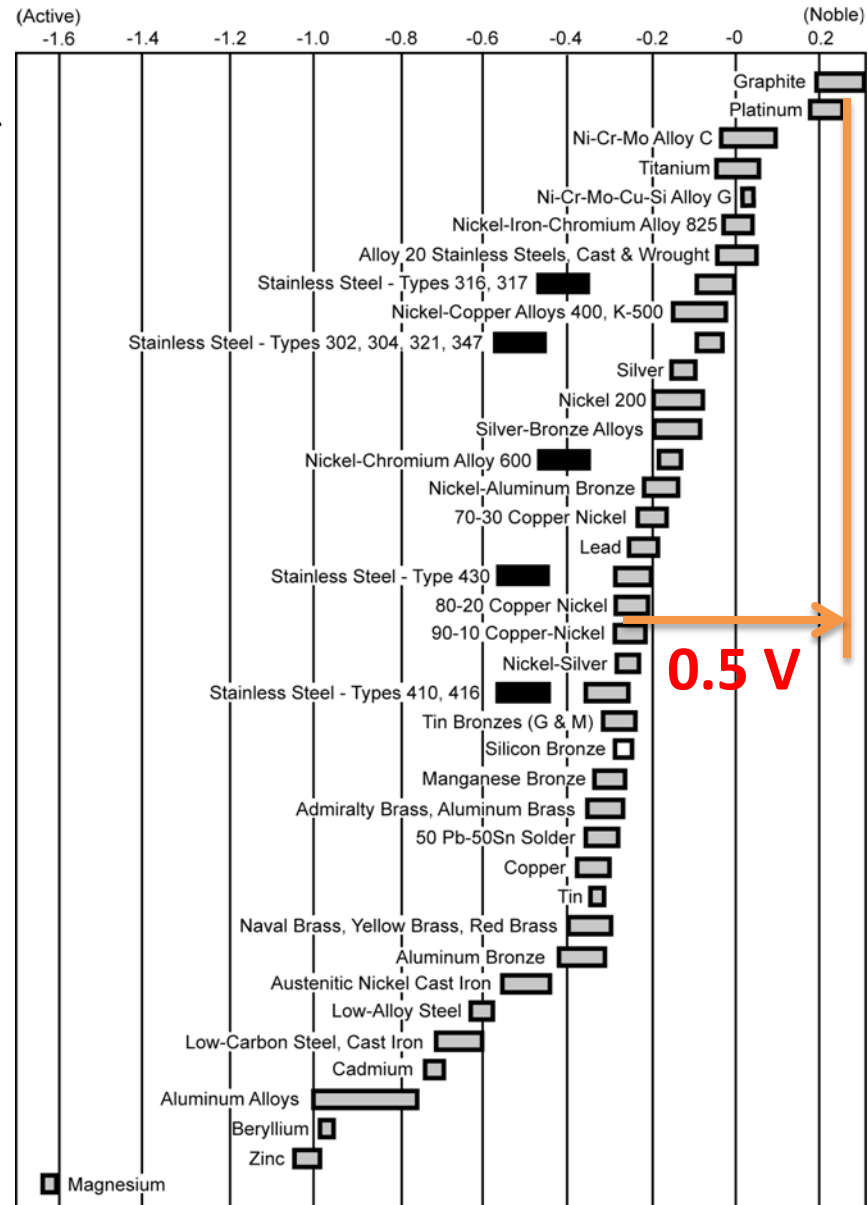
- In area of graphitic char, the Cu/Ni becomes the sacrificial anode!
- It's crucial to make sure that Cu alloy is clean

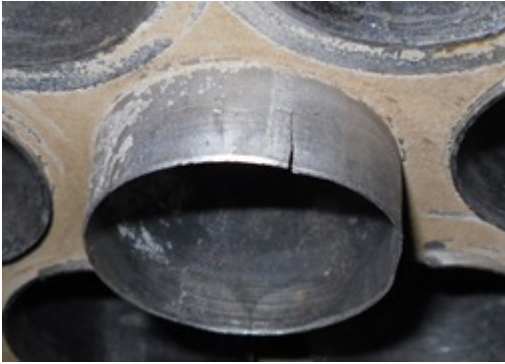
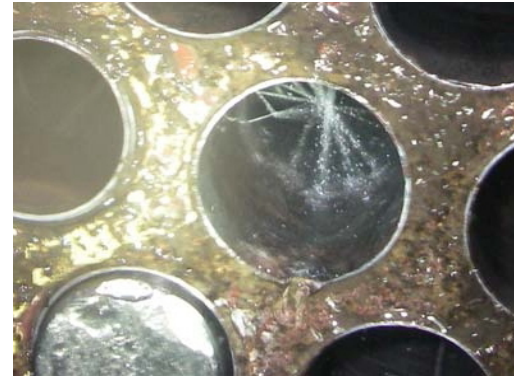
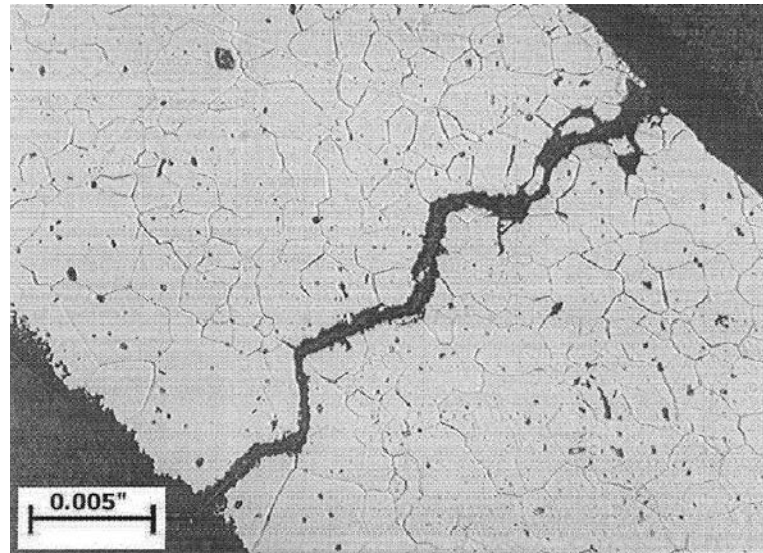
# Hydrogen Embrittlement – Super-Ferritic Stainless

- Can occur quite suddenly under shock condition
- Occurs near H<sub>2</sub> source which is usually at end of tube at rolled transition joint.
- Usually at outer tubesheet edge near anode

- In most cases – easy to prevent!
  - Keep impressed current system voltage less negative than -750 mv.
  - Don't use Mg based sacrificial anodes
- Super-ferritic embrittlement is reversible
  - Once discovered, eliminate source and ductility will return
- Ti embrittlement is not reversible
  - 8 entire condensers have been replaced.

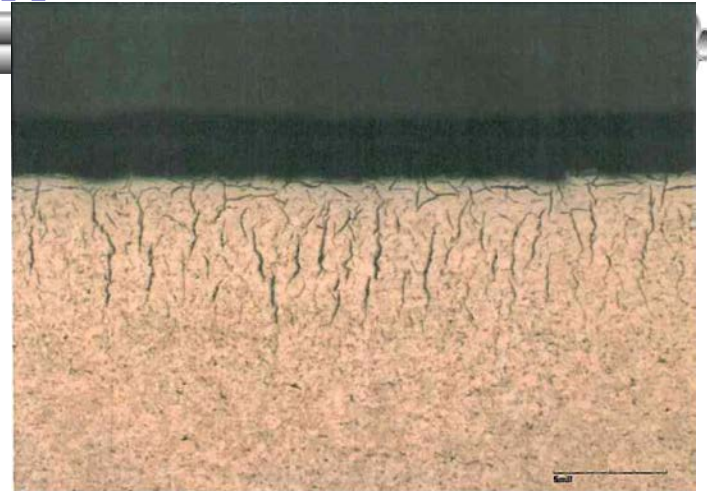
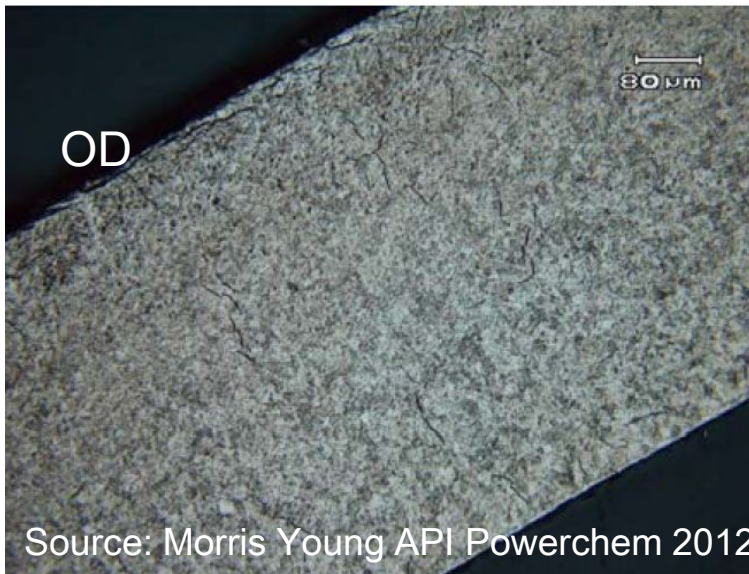
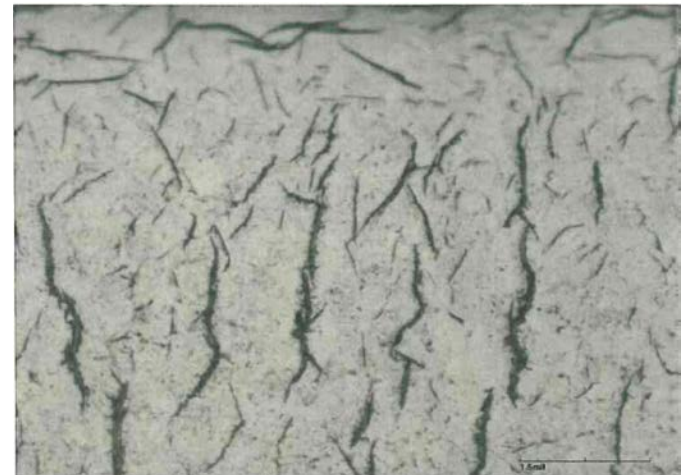
# Hydrogen Embrittlement – Titanium

- Growth in Ti is gradual
- Located mostly near source but area is more extended
- If cathodically induced, usually tubesheets are damaged at same time

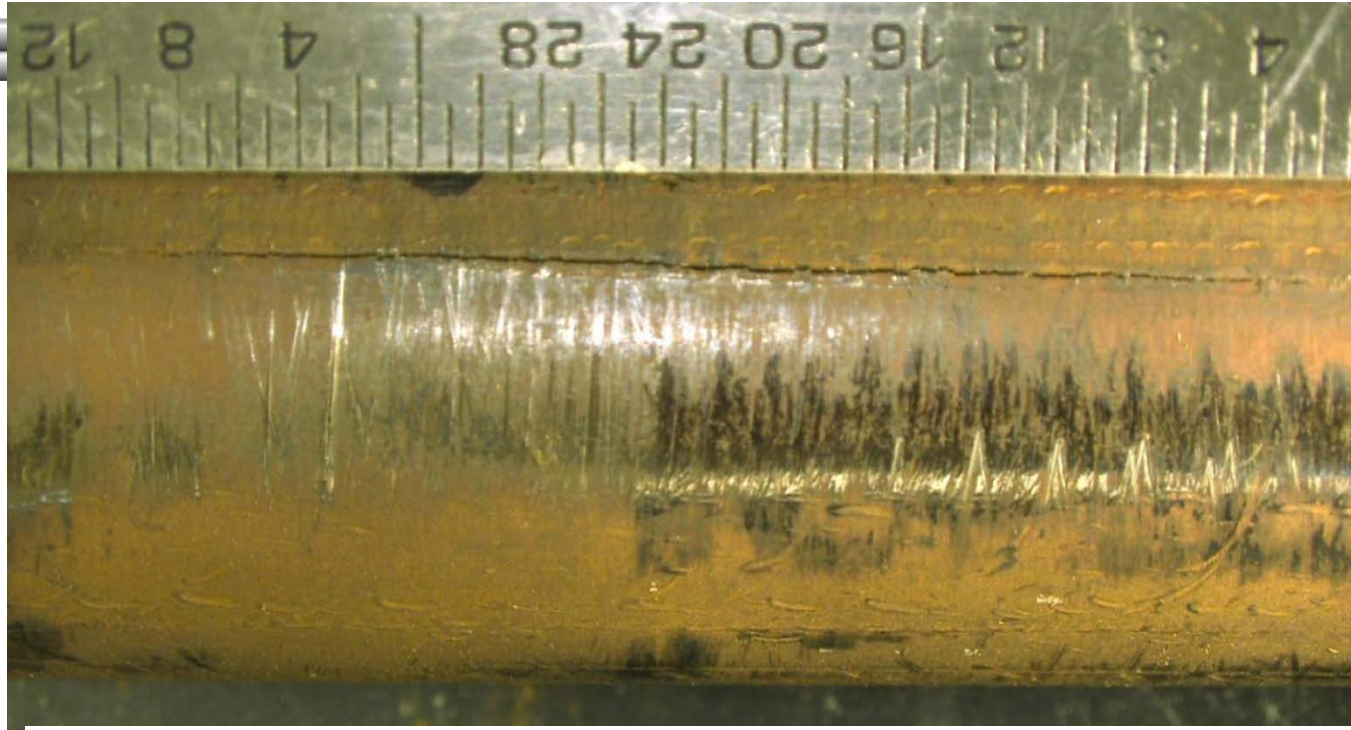
- Has been identified in 4 nuclear plants
- Random locations in the bundle
- Always associated with a longitudinal groove such as a scratch or weld depression

- Believed to be high cycle fatigue from “whirling” motion
  - Tube may be “ovaling” during whirl
- So far has only occurred to Ti
  - Ti has a low modulus and fatigue limit
  - May be accentuated by anisotropyprecaution in ASME Section II Part D para. A454

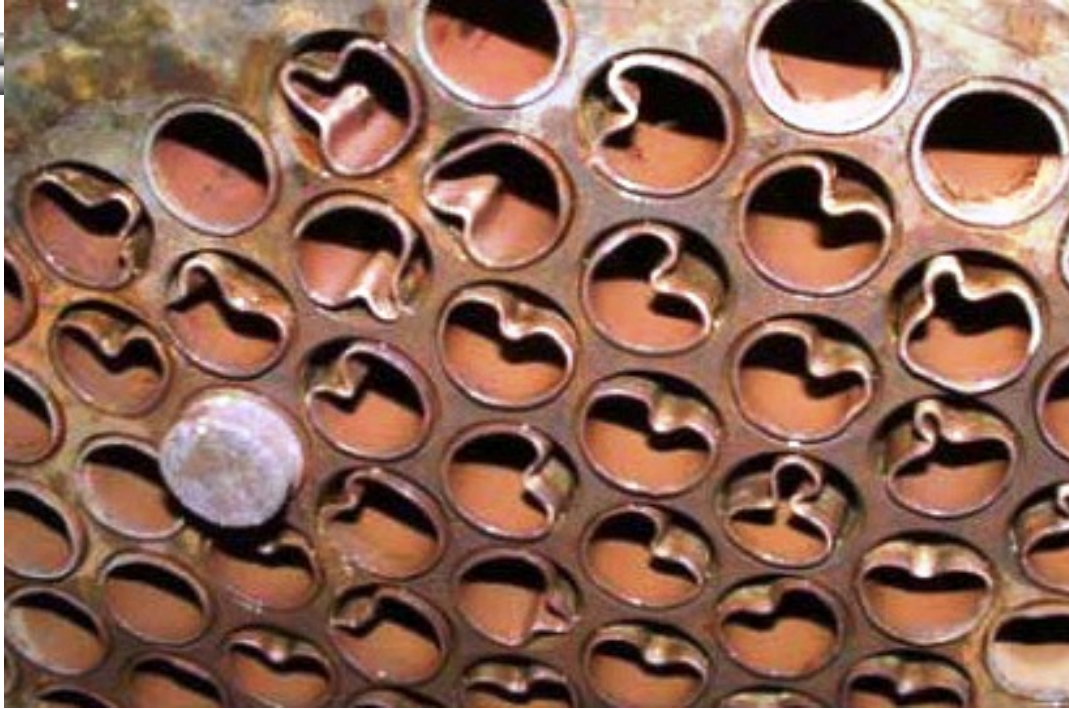
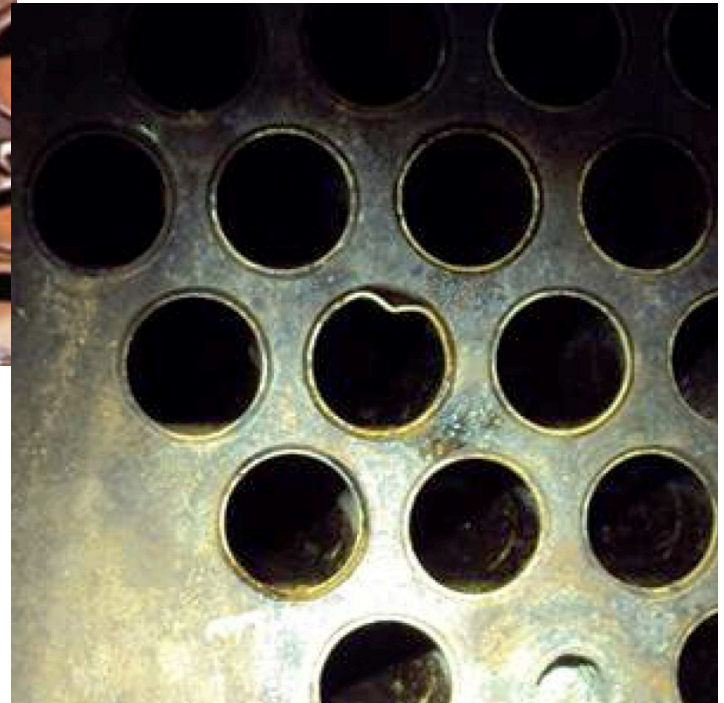
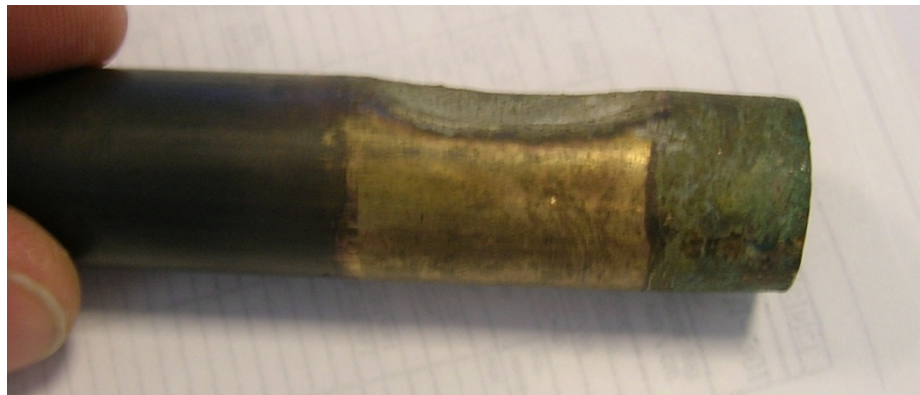
# *Cleaning Challenges*

- How to avoid?
  - Turn off wand before exiting and don't turn on until it's into tube!
  - Use other cleaning methods

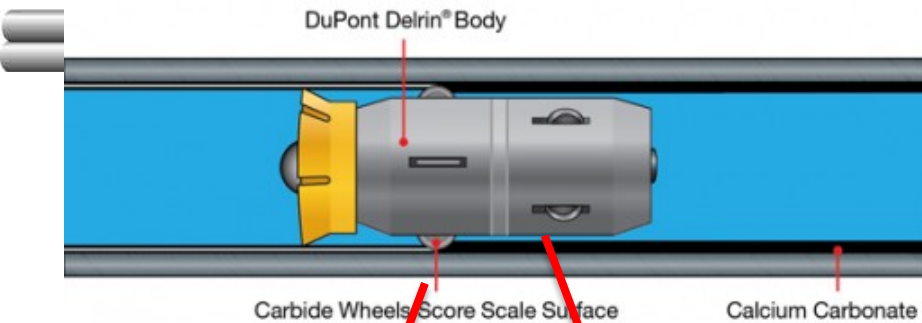
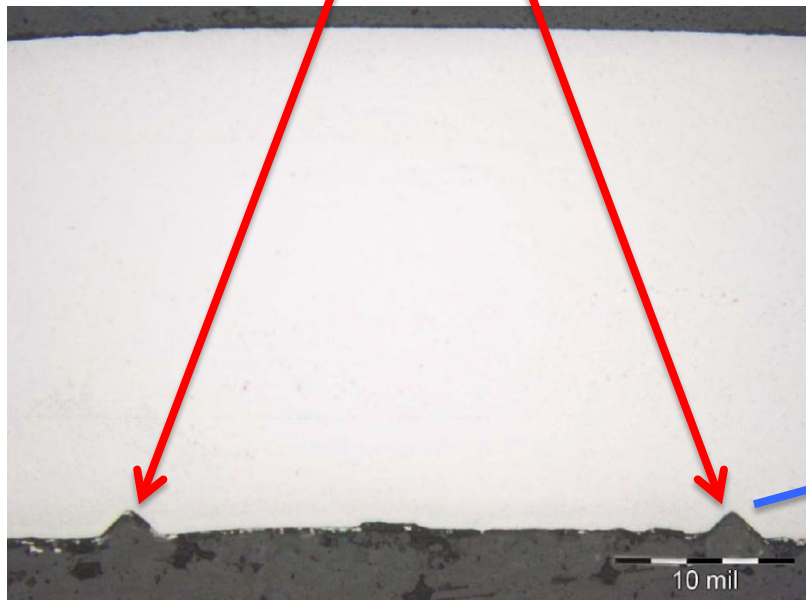
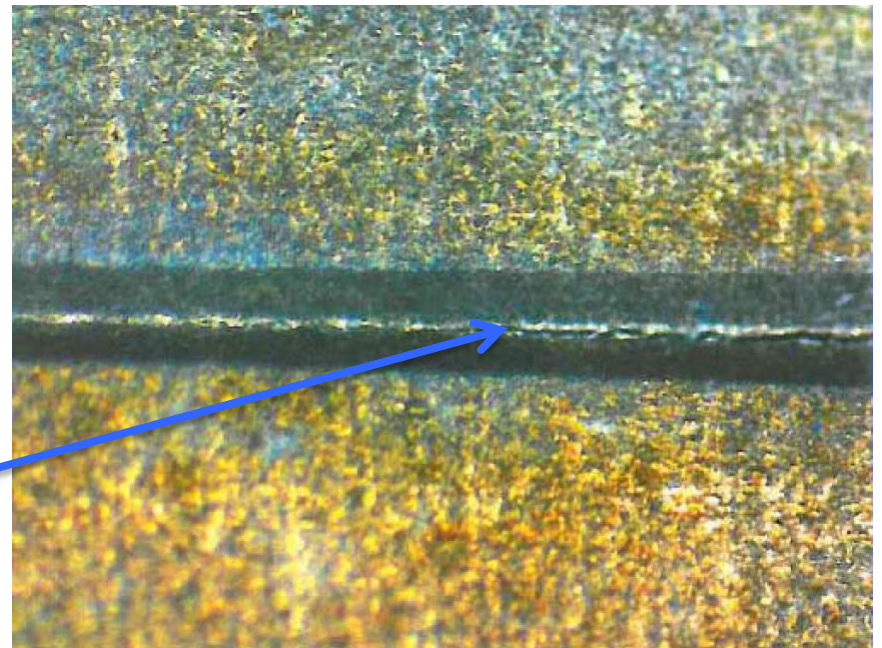
- Two Ti tubed plants  
now having failures  
from ID grooves
