Fractured MIL-PRF-55342 Resistors

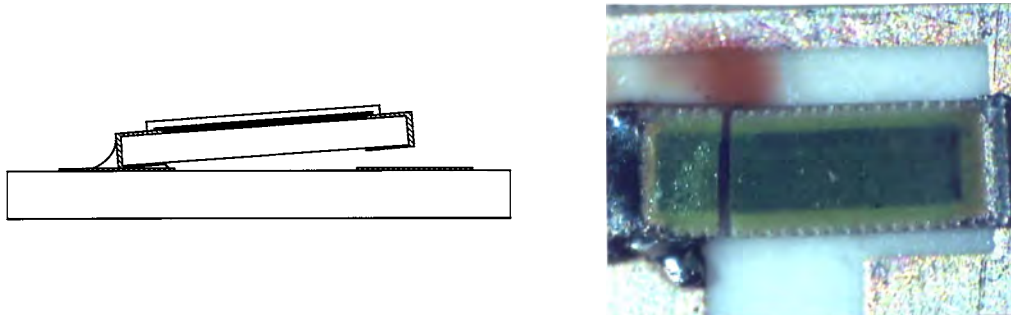
Figure 1. A diagram of a tombstoned resistor and a fractured RM1505 resistor after having force applied to the tombstoned end (2.8 to 5.1 kg force).

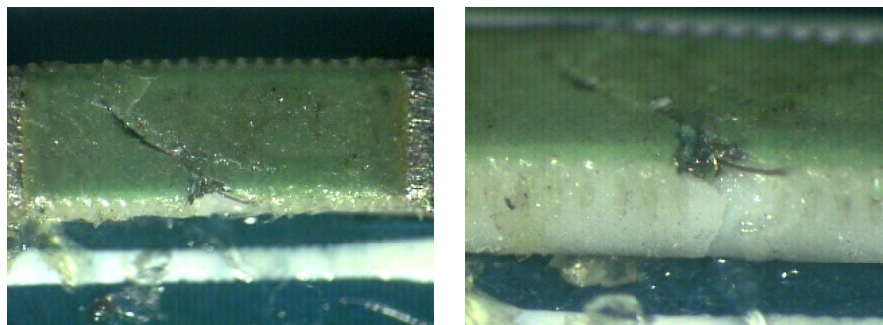
Figure 2. A broken RM1505 damaged by an impact event.

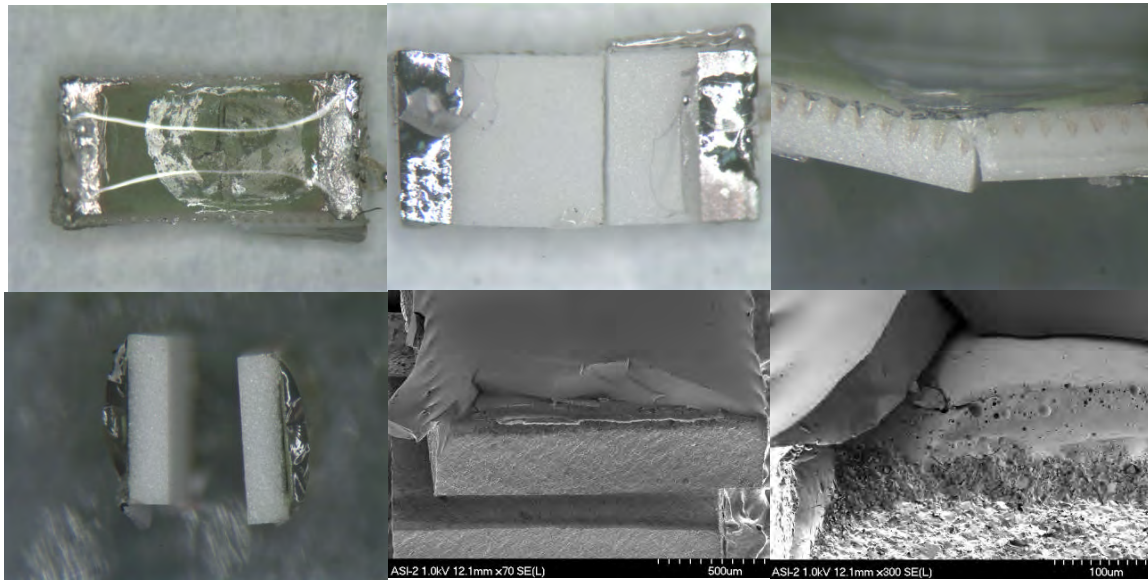
Several customers have reported broken MIL-PRF-55342 resistors on circuit boards with conformal coat. The devices are often broken midline but we have seen the fractures deviate $\pm 30\%$ of the case length from the midline. The fracture surfaces are free of any conformal coat material indicating the devices are broken after the boards are coated (Figure 3). Resistors with conformal coat break when the board is flexed. Performing board flexure on uncoated devices results in deformed or cracked solder fillets (Figure 4) but does not fracture the resistor.

Figure 3. A broken, coated RM1206 thick film device. SEM analysis found no conformal coat material on the fracture surfaces.

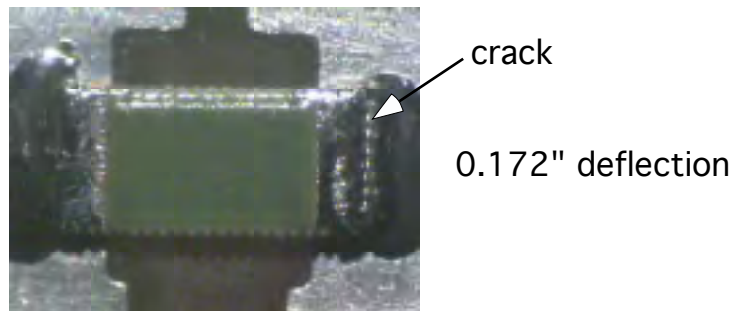
Figure 4. A RM1206 thick film device mounted on FR4 board showing the resistor to be undamaged and a damaged solder fillet after convex flexure.

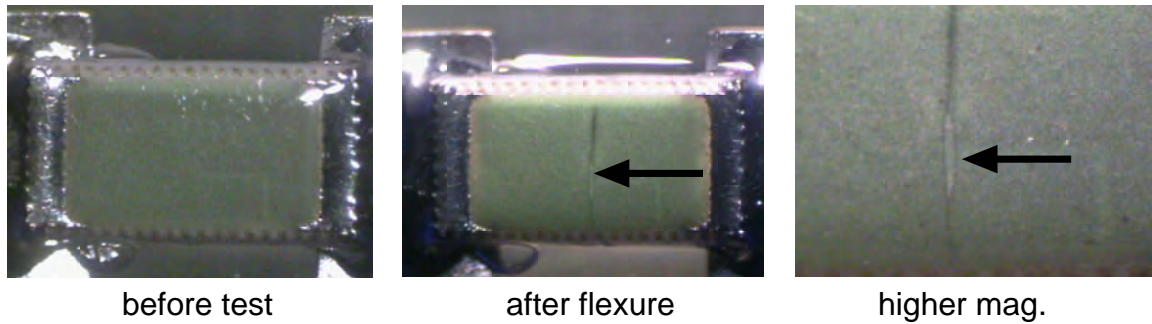
The appearance of the glass passivation material on the resistor provides clues indicating the direction of the flexure. The passivation material adjacent to the fracture is often spalled when the device is on the concave surface (Figure 5). Conversely, no spalling is evident when the device is located on the convex surface (Figure 6). The presence of conformal coat material changes the stress developed during a flexure event. The conformal coat pins the resistor and does not allow the solder fillet to deform during the flexure. The stress builds in the resistor until it fractures.

Figure 5. A coated, RM1206 resistor with spalling in the glass passivation adjacent to the fracture exposed to concave flexure.

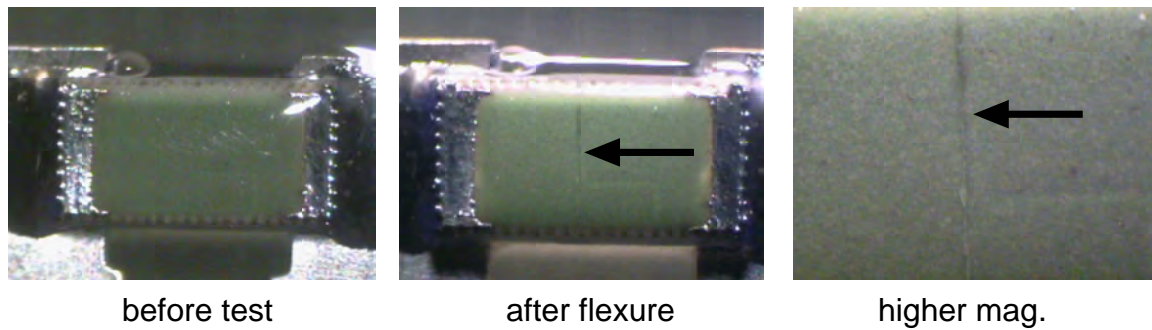
Figure 6. A coated, RM1206 resistor with a fracture but no spalling of the glass passivation exposed to convex flexure.
