# ES\_LPC1850/30/20/10 Rev A

Errata sheet LPC1850, LPC1830, LPC1820, LPC1810 Rev A

Rev. 4 — 25 January 2013

Errata sheet

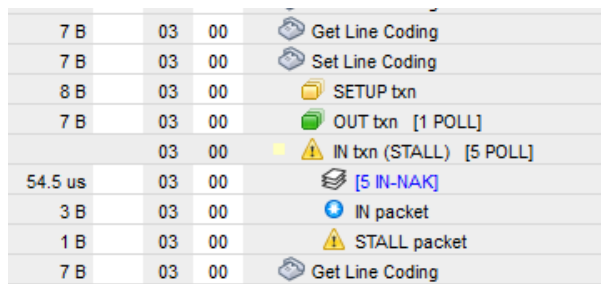
Fig 1. Incorrect

The CDC class USB ROM drivers return a STALL condition after the DATA stage of a Set Line Coding CONTROL transfer from the host. The correct behavior is to return an ACK.

The way to work around this bug is to override the default CDC class specific endpoint 0 handler and handle the processing of OUT packets in your application. Use the following source code in red to accomplish this.

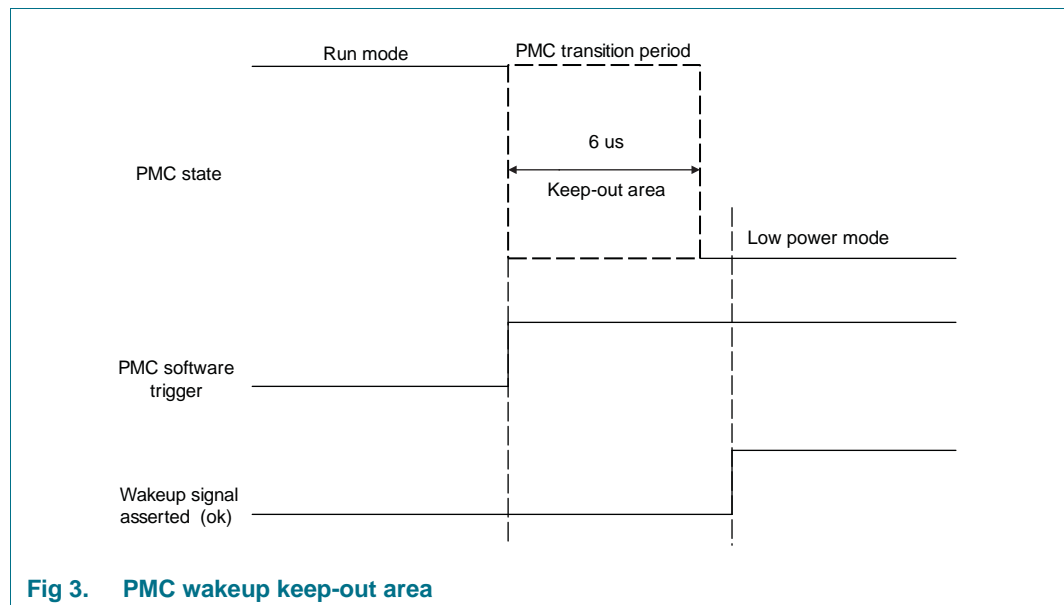
Fig 3. PMC wakeup keep-out area

When the chip is in a transition from active to Deep Sleep, Power Down, or Deep Power Down, wakeup events are not captured and they will block further wakeup events from propagating. The time window for this transition is 6  $\mu$ S and is not affected by the chip clock speed. After a wakeup event is received during the PMC transition, the chip can only recover by using an external hardware reset or by cycling power.

Make sure that a wakeup signal is not received during the Deep Sleep, Power Down, or Deep Power Down transition period. An example circuit to work around this could include an external 6  $\mu$ S one shot which could be triggered via software using a GPIO line when entering Deep Sleep, Power Down, or Deep Power Down mode. The one-shot's output could be used to gate the wakeup signal(s) to prevent receiving a wakeup signal during the PMC transition period. Depending on the system design, it may also be needed to latch the wakeup signal(s) so that they will still be present after the one-shot's 6  $\mu$ S timeout.
