POLYTERM® FLEXIBLE SMD TERMINATION

CHRISTOPHER ENGLAND APPLICATIONS ENGINEER / HVS PRODUCTS

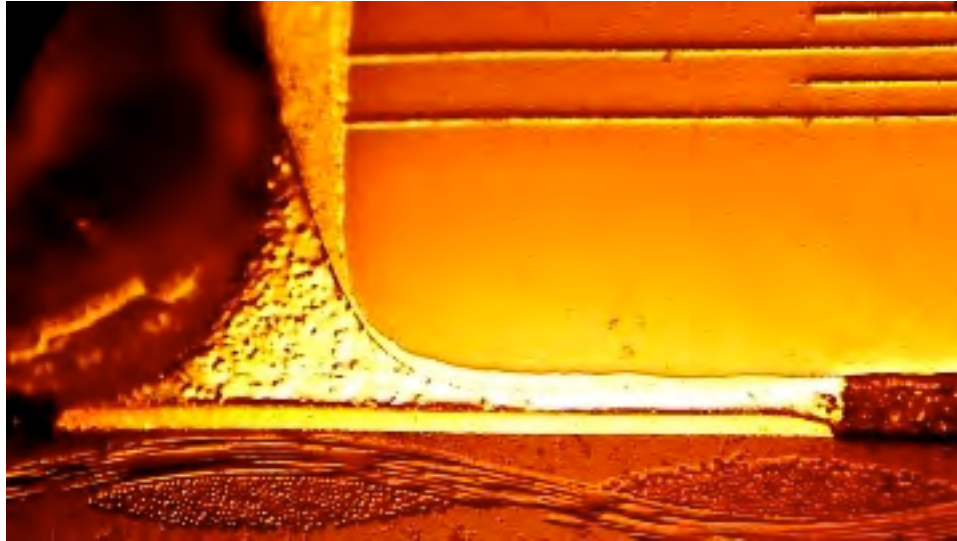
Figure 10 Undamaged termination 1mm deflection

Group 2) Samples were bent to varying degrees of deflection to provide photographic representation of how the polymer terminations perform and illustrate how failures manifest themselves. This test was performed using the S47 (2220) sample group (figures 10-14). One board for each mm of deflection was used.

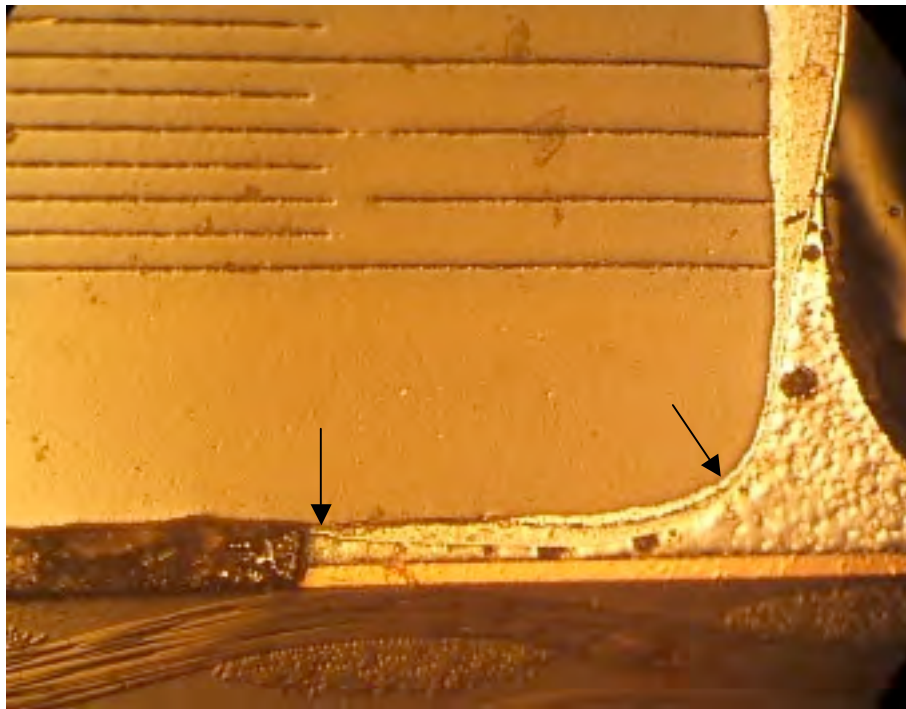
Figure 11 Partial separation of polymer 3mm deflection.

At 3mm only partial separation of the polymer was visible. The silver layer is clearly separating from the polymer with no ceramic damage visible.

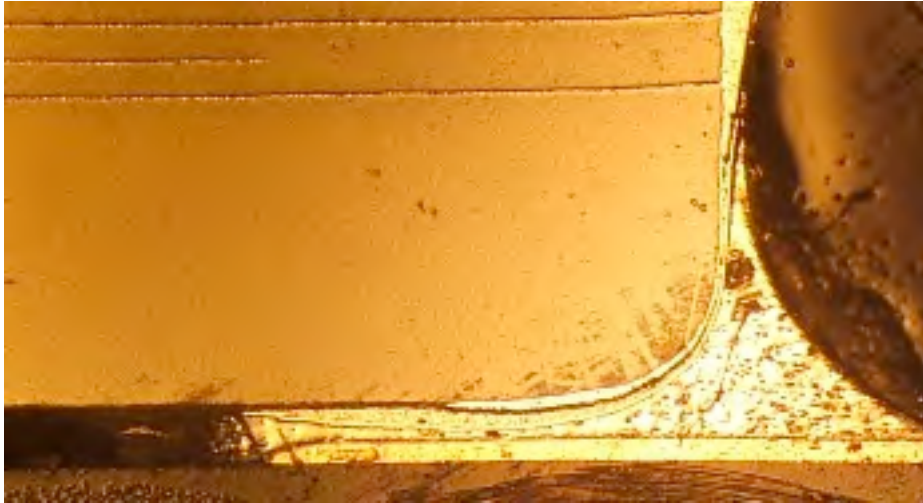
Figure 12 Partial Separation of Polymer 4mm

The photo in Figure 12 shows almost complete separation of the silver termination from the polymer layer. Although the polymer layer is partially separated the capacitor still operates normally. When returned to the original state all capacitors regardless of failure operated within specification.

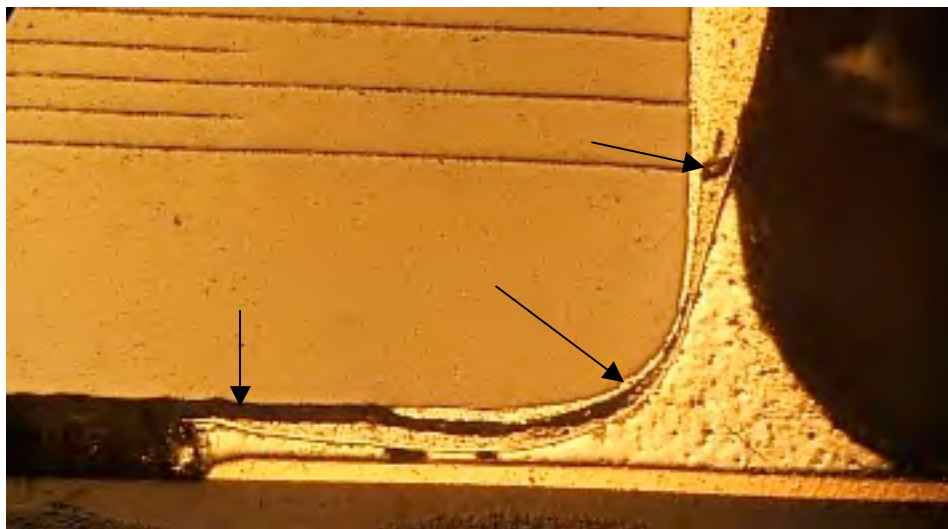
Figure 13 Complete Separation of Polymer Layer 5mm

Complete separation of the polymer layer may cause open capacitor, but ceramic failure was not observed. This will protect against the capacitor failing short causing catastrophic failure.

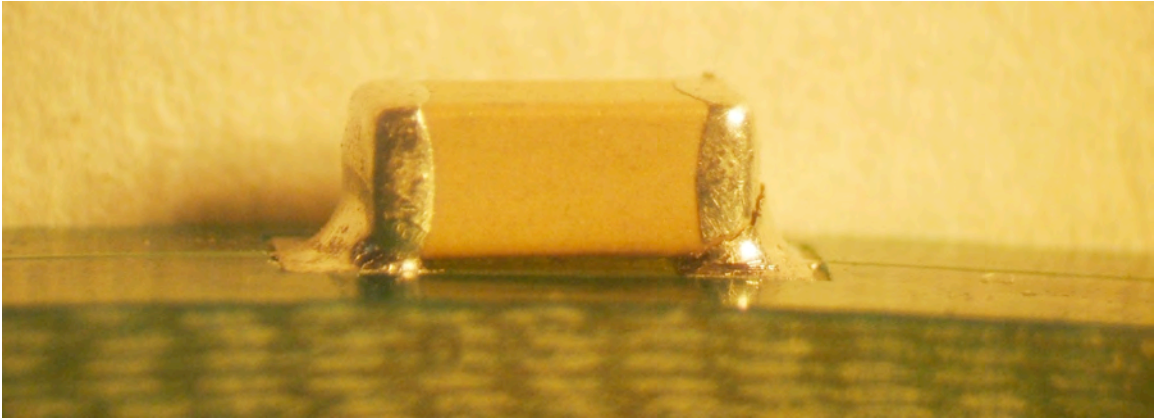
Figure 14 Capacitor with complete separation of Polyterm[®] termination during flex testing.

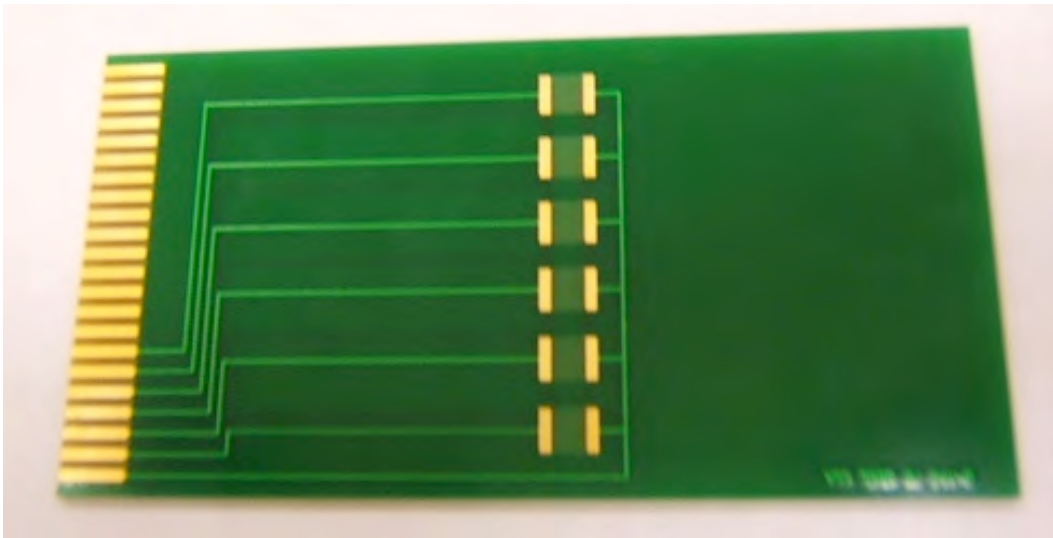
Figure 15 Flex Test Board

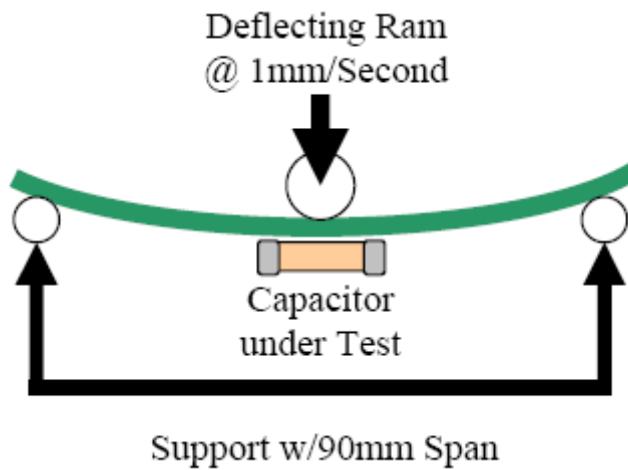
Figure 17 illustration of bend test
