Silicon Carbide Defects

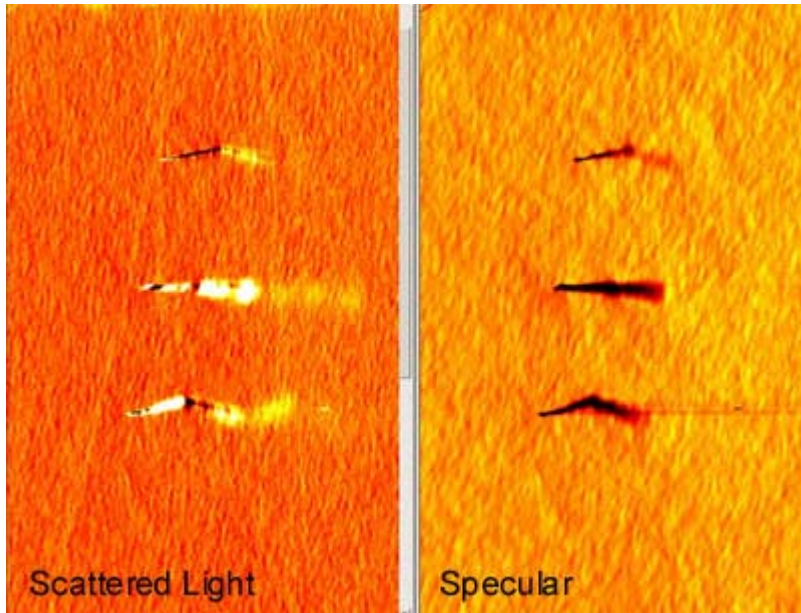
KLA-Tencor's Candela Optical Surface Analyzer (OSA) provides rapid process feedback and quantitative analyses to accelerate product development and assess valuable starting material. Using the multiple detection channels enables differentiation between surface contamination and crystal defects. This example shows the scattered light (left) and reflected light (right) images of three large micropipes. Because they extend for a long distance and the wafer is semi-transparent, the micropipes have a characteristically elongated appearance. Using this optical signature, they can be readily differentiated from particles and other defect types.
