### Tool Kit Contents

### Tool Kit Setup

## Fiber Preparation

# Polishing

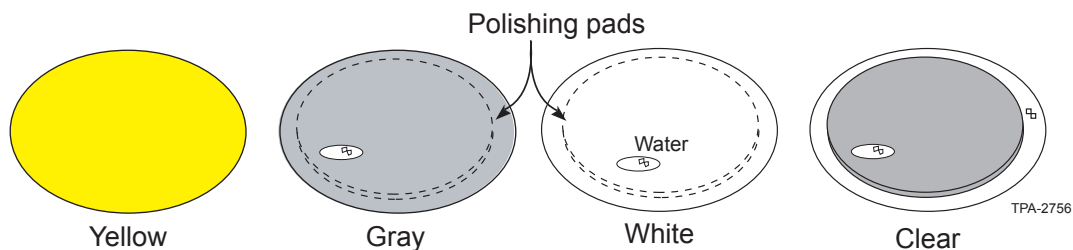
Figure 1 — Polishing film preparation: pads under Gray, White and Clear.

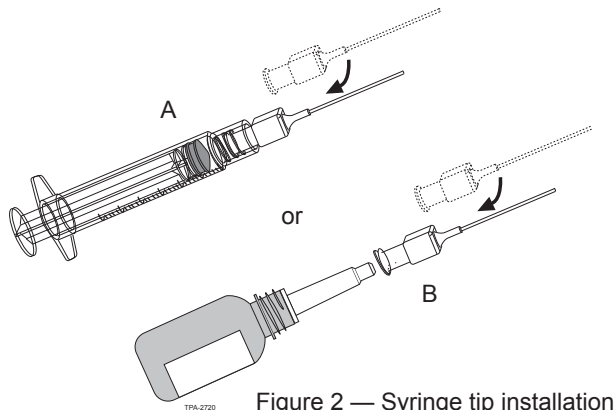
Figure 2 — Syringe tip installation

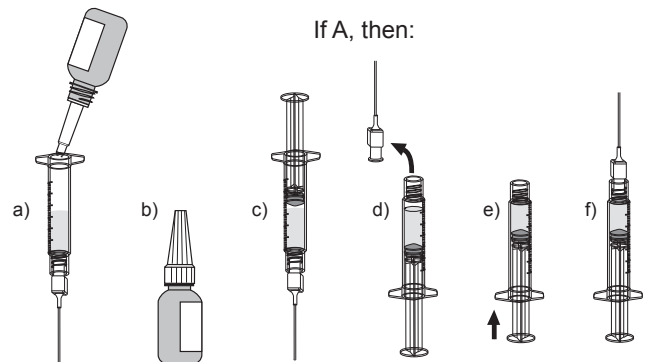
Figure 3 — Syringe preparation

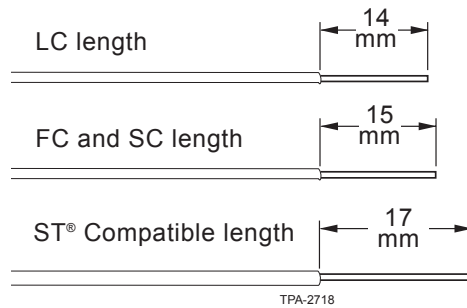
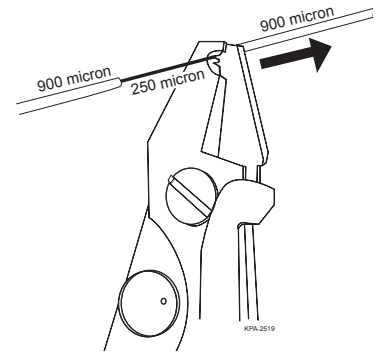
- 1 Slide boot onto fiber first.
- 2 Measure to lengths shown and then strip with Dual-Hole Miller Tool.
- 3 Strip fiber and then clean.

- Fiber stripped too long; use lengths in step 2.
- Too much adhesive used; stop when adhesive is barely visible on end face.
- Adhesive curing too quickly could be caused by several possibilities:
  - Check expiration dates on both adhesive and primer.
  - If working in extreme high-heat / high-humidity conditions consider not applying the primer.

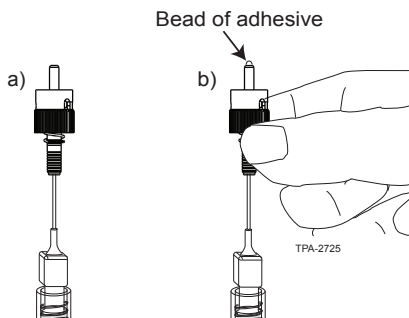
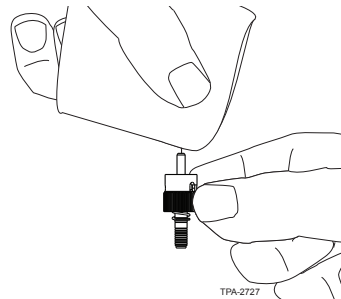
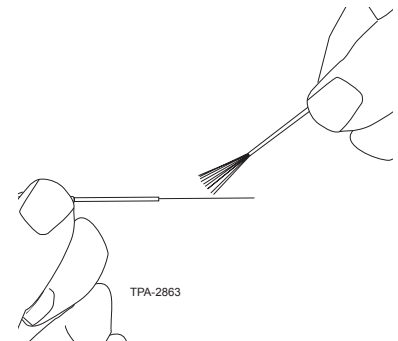
- 4 Inject adhesive until adhesive is barely visible; remove syringe tip.
- 5 Remove excess adhesive with lint-free wipe.
- 6 Apply primer to bare fiber.

Try to avoid getting primer on any of the fiber/cable other than the bare fiber.

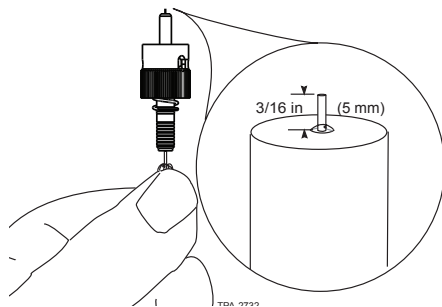
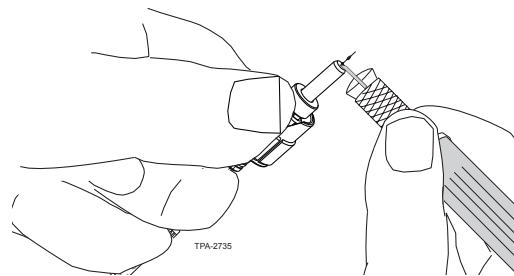
- 7 Insert fiber into connector until it bottoms out. 3/16 inch should be visible above the end face.
- 8 Gently slide the ruby scribe across edge of fiber and remove fiber fragment with tweezers.

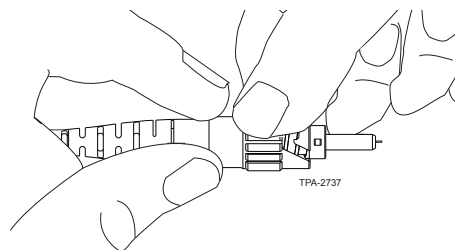
- 9 Slide boot up onto back of connector.

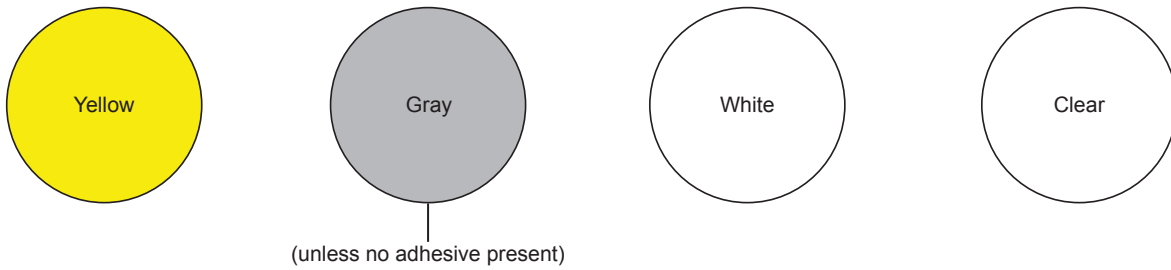
Figure 4 — Polishing film order

**10** Remove fiber nub with 1-inch circles on the yellow film. Stop when the nub doesn't scratch the film anymore.

**11** Insert connector in polishing puck.

**12** Check for a small amount of adhesive.

Skip Gray polishing if no adhesive is present after Step 12.

**13** Complete one or two initial passes with very light pressure to ensure fiber nub is flush with adhesive bead.

**14** Make one figure-8 pattern at a time; check size of adhesive bead every time. Stop when bead is NEARLY gone.

- Improper excess fiber removal techniques.
- Inadvertent fiber breakage before or after scribing. Take care to protect the fiber.
- Excessive pressure on yellow polishing film.
- Excessive pressure on gray polishing film.

- Small crescent-shaped cracks will occur when the gray polishing film is worn. Replace film and start over.

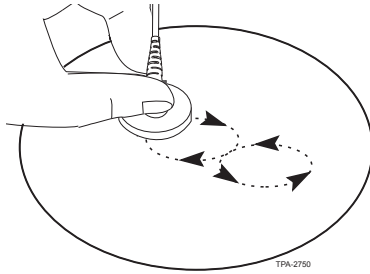
18 Make between 10 and 15 figure-8 patterns on CLEAR polishing film. Try to use NO pressure here.

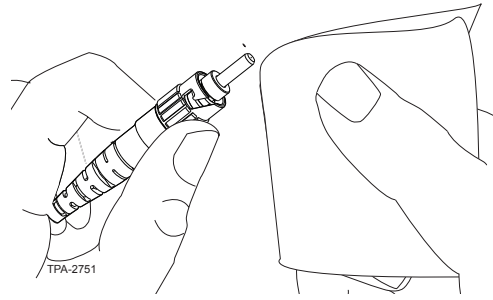
19 Clean connector with alcohol and wipes. Finish cleaning with a dry wipe.

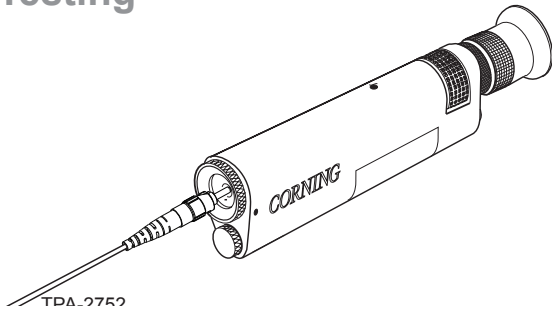
20 Insert connector into 200x microscope or probe. (See Figure 5 for acceptable results.)

21 Test with OTDR for Connector loss and reflectance.  
Test with power source and meter for end-to-end attenuation.

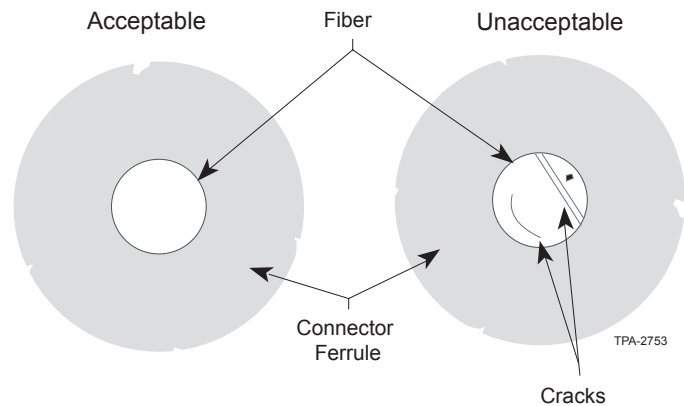
Figure 5 — Acceptable End Face. End face should look like left image. If you see right image, consult Troubleshooting section.
