## ENGINEERING CHANGE NOTIFICATION FORM

ECN: 100-001-000126	REV: 1	ISSUE DATE: 3/18/2014				
TYPE OF CHANGE: Firmware Modification						
<b>DETAILED DESCRIPTION OF CHANGE:</b> Firmware release 0.71 for CSAC boards includes improvements in the LCD interface including additional LCD pages, improved key debouncing, and user feedback when starting the position survey. Release 0.71 also addresses bugs related to starting the survey, and SCPI interface format issues.						
<b>REASON FOR CHANGE:</b> Functionality improvements, added features and bug fixes.						
<b>PRODUCTS AFFECTED:</b> <table border="1" data-bbox="131 705 1458 890"> <thead> <tr> <th>Firmware Version</th> <th>Model</th> </tr> </thead> <tbody> <tr> <td><b>Firmware 0.70a and previous versions for CSAC</b></td> <td>           CSAC <sup>1</sup>            HD CSAC <sup>1</sup>            LN CSAC <sup>2</sup>            DROR-II <sup>2</sup> </td> </tr> </tbody> </table>			Firmware Version	Model	<b>Firmware 0.70a and previous versions for CSAC</b>	CSAC <sup>1</sup> HD CSAC <sup>1</sup> LN CSAC <sup>2</sup> DROR-II <sup>2</sup>

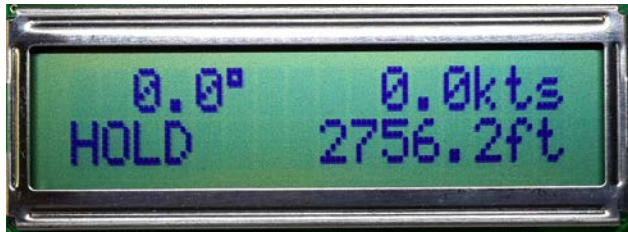
**Navigation Page**

Additional LCD pages were added including the Navigation Page, UTC/GPS Time Page, and the previously mentioned Survey Status Page. The Navigation Page includes heading, speed, dynamics state and altitude. The UTC/GPS Time Page includes UTC time, GPS time and the leap second offset. The Survey Status Page includes survey status, duration and position variance. Below are examples of the three added LCD pages.
