## AD-here Blended Additive—Project Profile, Erie County, PA

### AD-here LOF 65-00<sup>®</sup> with CECABASE<sup>®</sup> RT 945

Project Location: Route 505 Erie County, PA

Date Placed: July 2012

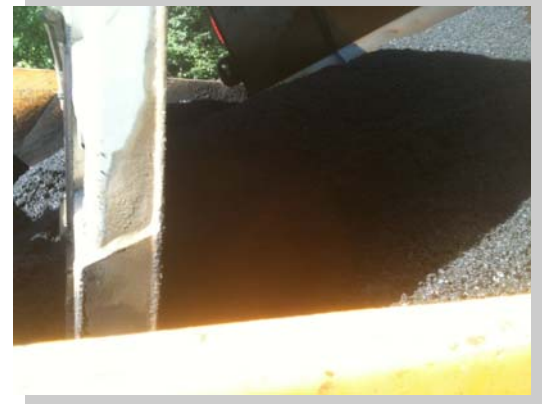
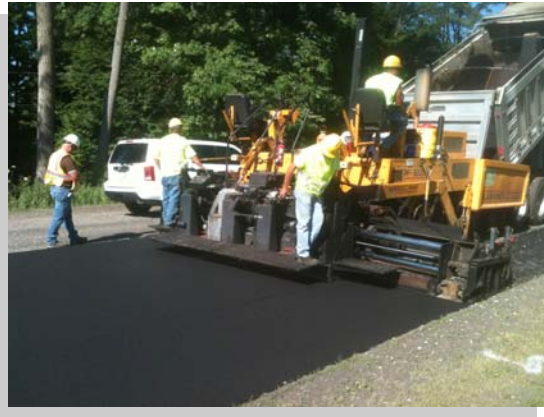
Mayer Bros. elected to pave the Northbound travel lane (12 foot width) and Northbound shoulder (4 to 5 foot width) in a northbound direction with the flow of traffic.

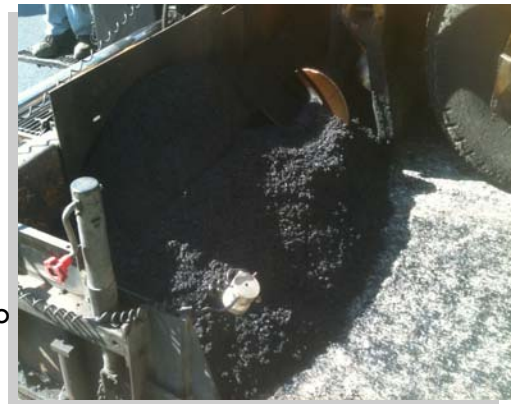
Workability of the warm mix replicated a conventional hot mix. The material dumped easily into the paver hopper, passed through the paver to the screed and was struck off to grade with absolutely no difficulty. The mat was very consistent in finished texture coming out of the back of the screed. Where handwork was necessary, the laborers doing the shoveling and luting, commented that the mix was very friendly. Other observers noticed the same "user friendly" capabilities of the mix. Target thickness of this Scratch Course was for a little over 1/2" (60 lb/sy). Due to inconsistencies in the milled surface the average depth across the mat was running about 3/4" with placement of the first three loads of mix by the fourth load the thickness was running closer to 1/2" to 5/8" and remained consistent through the next 17 loads.

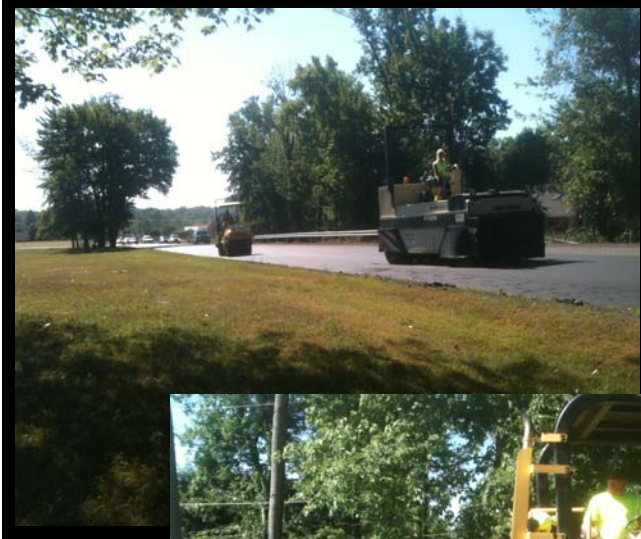
The rolling train consisted of a 12 ton steel wheel double drum Sakai SW850 as the breakdown roller, an Ingersol Rand 271 Rubber Tire Roller as the intermediate and a small 4 ton steel wheel double drum Sakai SW320 as the finish roller. Since this was a scratch course; PennDOT does not hold the contractor to any minimum density requirements. All rolling passes with the breakdown and finish rollers were done in static mode. The pattern consisted of one static movement up and one static movement back on each pass before moving over to start the next pass. Rolling was done from the high side to the low side across the mat.

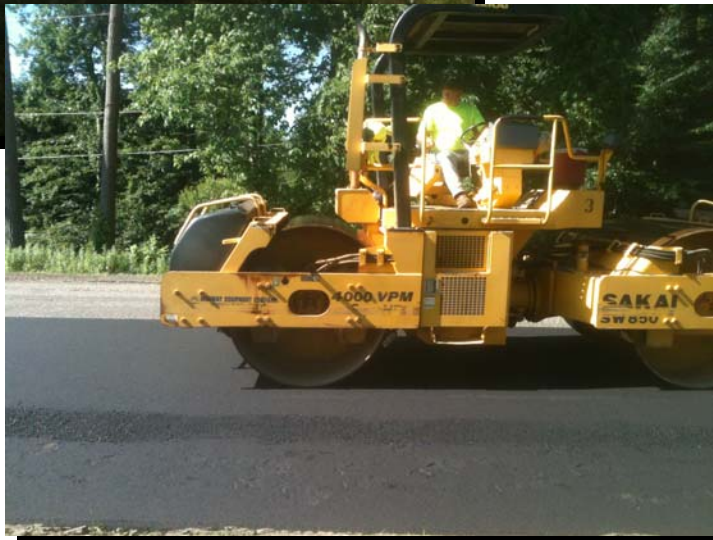
The average load temperature over the three and one half hour time was 256 F, with a high temperature of 263 F and a low of 245 F

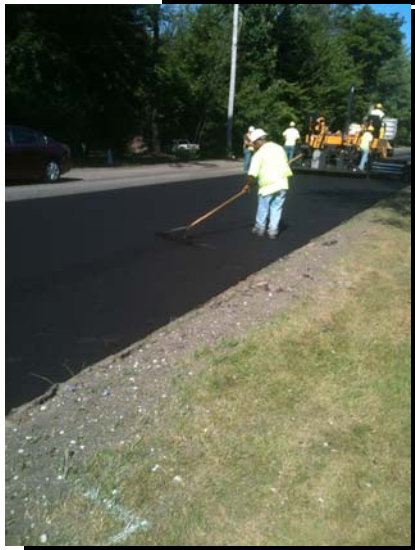
It was also observed that when pushing the surface of the mix to the side and taking a temperature reading lower in the mat thickness that the readouts were almost identical to the surface temperature; either the same as the surface or within a degree or two of the surface temperature. This seemed to indicate that the mix was receiving a consistent introduction of the additive at the asphalt plant. It was also noted that the trailing flagman in the operation was within 3 loads of the paver at any given time.
