JOHANSON DIELECTRICS INC.

Arc Season and Board Design Observations

John Maxwell, Director of Product Development, Johanson Dielectrics Inc.

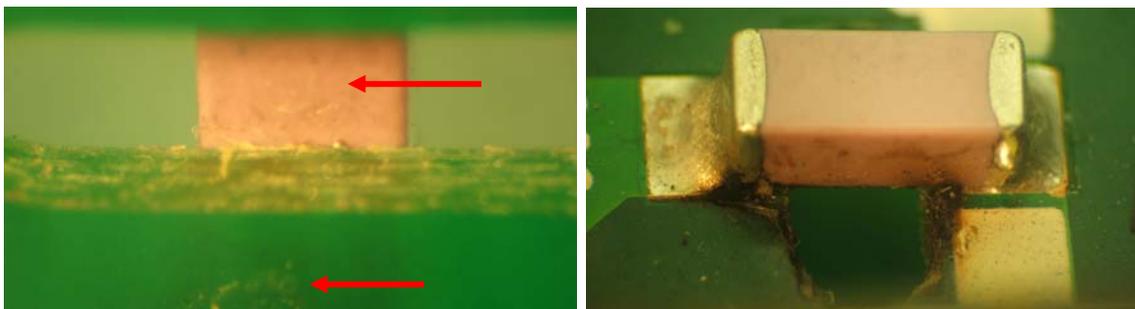
Figure 1. Field Failure Due to Water Soluble Flux Residue

a) Flux Residues on Chip & PWB Bottom

b) ARC Path in PWB Slot

Problems include test equipment correlation problems, test methods used for HV testing, but the big source of defects appear to be from a combination of the board layout, assembly process, choice of solder paste flux and cleaning where required. A large number of contract manufacturers around the world use water soluble flux solder paste because it is much more aggressive than No-Clean flux allowing for wider reflow process windows and minimizes component solderability problems. Unfortunately organic acids used in water soluble solder paste are very active and if the assembly is not adequately cleaned those flux residues start their damage and are difficult to remove. Now we are faced with high leakage currents, low arc voltages and assembly failures. Add humidity and we have a new ARC season. An interesting ARC season failure is shown in Figure 1. The board was reflow soldered using water soluble solder paste but not completely cleaned. The board design used a 2mm slot beneath 1808 case size high voltage safety capacitors. The use of slots are a typical high voltage board design technique. Complete and thorough cleaning of all flux residues is mandatory when this design technique is used with water soluble flux. There were droplets of flux residue on the assembly bottom and visible flux residues on the bottom of all 1808 size safety capacitors. The burned arc path shown in Figure 1 is along the slot edge in the PWB following flux residues.

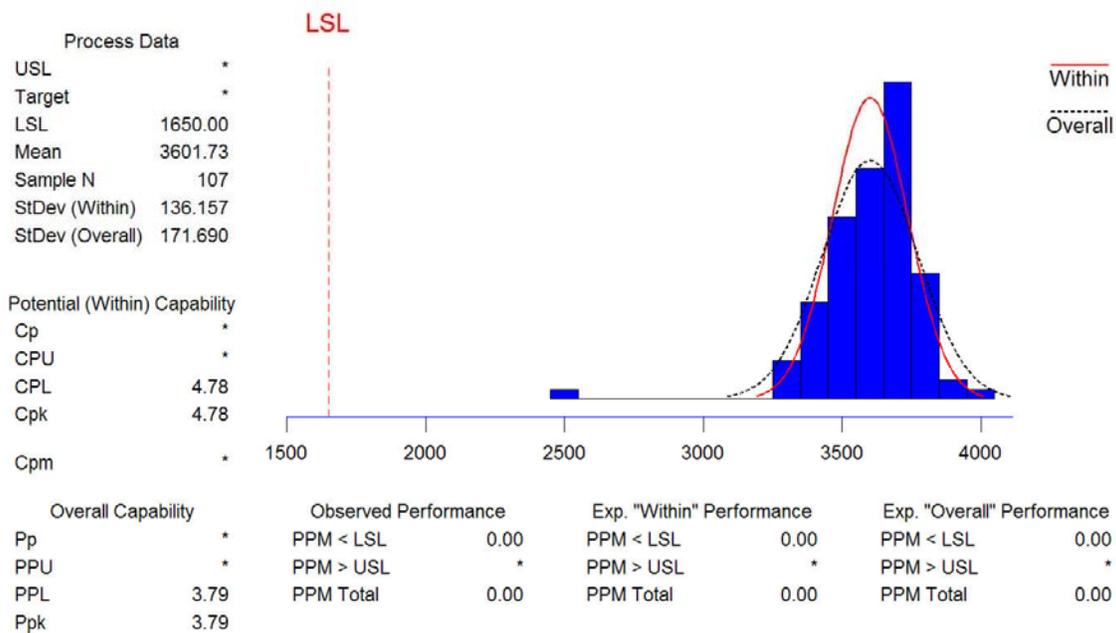
Figure 2. AC Breakdown Results for Test Lot of 302R18W121KV4 Capacitors

Process Capability Analysis for 302R18W121KV

These capacitors chosen for this experiment are 1206 case size X7R 120pF and are designed for 1500VAC withstanding voltage commonly found in larger safety capacitors. A 107 piece sample of these parts was tested to AC breakdown with the results shown in Figure 1.

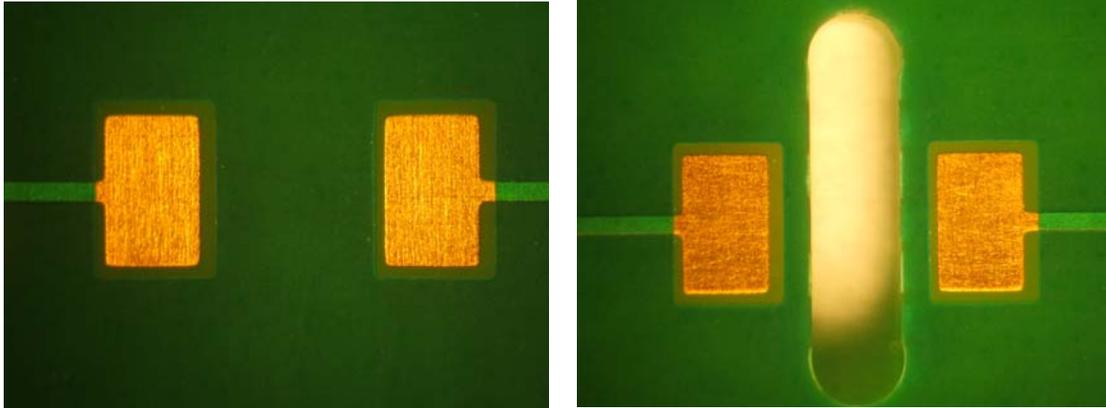
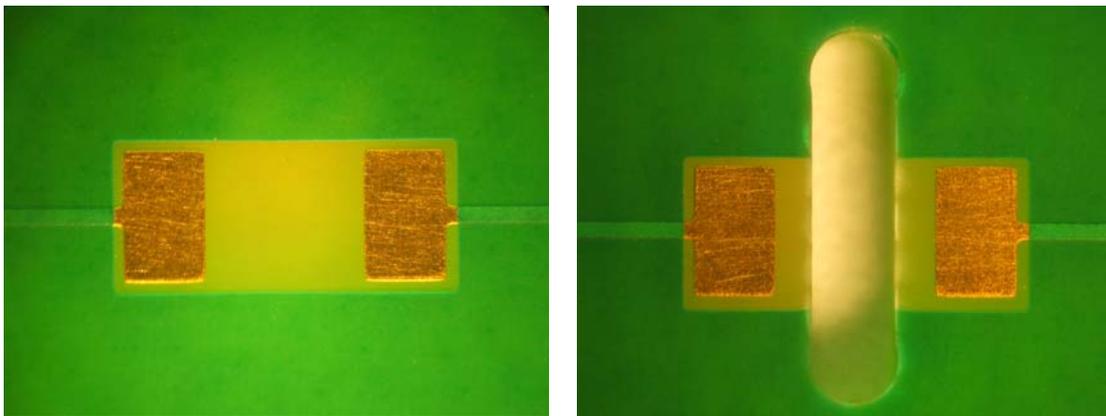
Figure 3. Evaluation Board SMT Pad Variations

a) Solder Mask between Pads

b) Solder Mask & Slot between Pads

c) No Solder Mask between Pads

d) No Solder Mask but Slot between Pads

Board layout variations included solder mask between pads, no solder mask between pads, solder mask with a 0.040" (1mm) wide slot between pads and no solder mask with a 0.040" slot between pads. A larger slot was not practical for 1206 sized capacitors because of pad to pad spacing of 0.080" (2mm) was used. Figure 3 shows each layout variation for reference. Removing solder mask from between pads allows solvent access during cleaning when water soluble flux is used and minimizes flux flow between the capacitor pads due to capillary forces during reflow soldering.

Square pads were used as they are most commonly encountered on end customer's boards. Additionally square pads are the easiest to draw in board layout programs. Each evaluation board had 80 positions for each pad/solder mask/slot variation for increased confidence levels in the results. Bare board arcs were from pad corner to opposing pad corner as expected as square pad corners will have the highest electric field gradients.

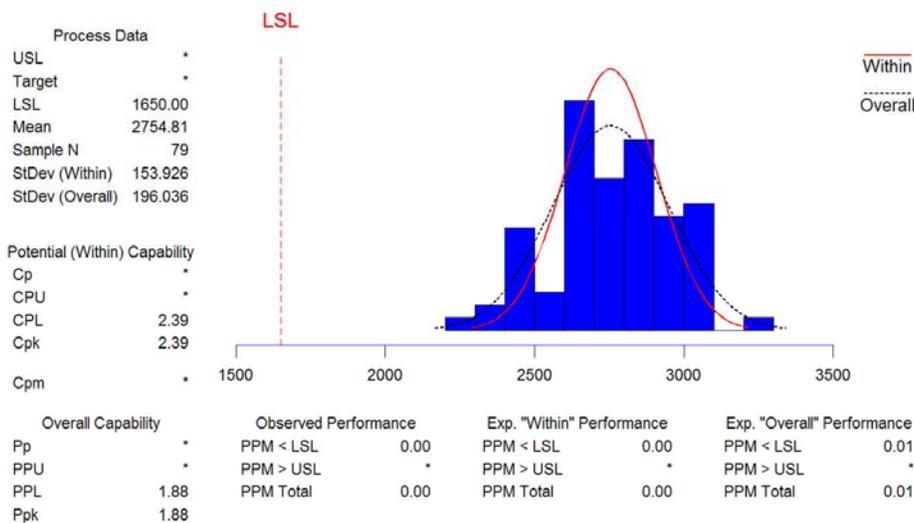
Figure 5. AC Breakdown Distribution 48 Hours 85°C/85%RH Exposure

Water Soluble Solder Paste, No Solder Mask with 1mm Slot

Examining both the mean of the breakdown voltages and the actual distributions shown in Appendices 2 and 3 are revealing. Solder mask between pads was consistently the poorest performer in AC breakdown testing in these experiments. Slots between pads were consistently the best performers as expected. No solder mask between pads was comparable with the layout option of solder mask and a slot between the capacitor pads. Figures 4 and 5 are the distributions for No-Clean solder paste with no solder mask between pads and water soluble solder paste with solder mask between pads with a 0.040" (1mm) slot. Both assemblies underwent 48 hours exposure at 85°C/85%RH.

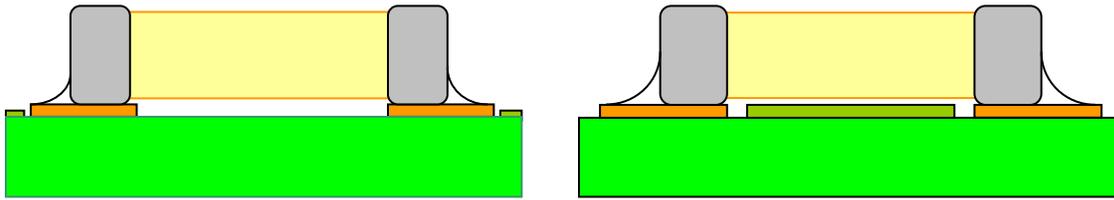
Figure 6. Solder Mask Layout Options

The data are consistent with eliminating high voltage slots where allowed and removal of solder mask between pads. Figure 6 represents a chip soldered to pads with and without solder mask showing the added gap between chip bottom and PWB surface.

a) No Solder Mask between Pads b) Solder Mask between Pads

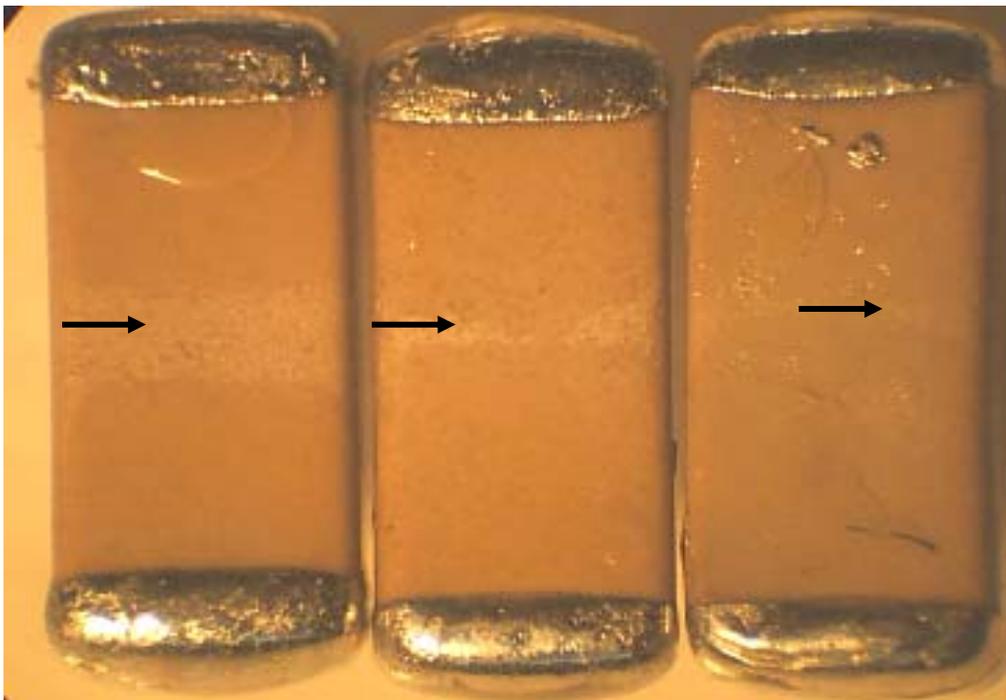
Figure 7. Bottom Side of Capacitors Showing Trapped Flux Residue Leading to Failure

Flux residues are trapped between capacitor bodies and solder mask during reflow soldering when the flux is liquid. This is due to capillary forces wicking the flux between the solder mask and capacitor body. Figure 7 shows three parts removed from a board that suffered ARC season defects. The flux is clearly visible in this photo. The parts were removed by placing the assembly on a hot plate and were plucked off using tweezers when the solder reflowed. These particular boards had a 2mm slot between pads but failed 1500VAC during HiPot testing. Bottom side of capacitors showing flux residues trapped between capacitor bodies and solder mask. The flux flow stopped at the PWB slot and has arrows pointing to the flux gaps.

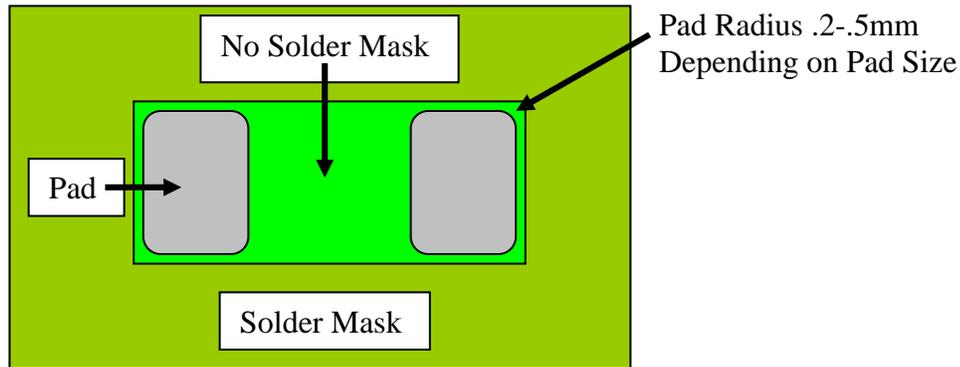
Figure 8. High Voltage Surface Mount Pad Radius Suggestions

In addition to eliminating solder mask between pads, the pads themselves should have radiuses instead of rectangular corners. All arcs emanated from pad corners due to those locations having the highest electric field gradients when exposed to high voltage fields. Adding a radius at each corner will reduce field gradients aid in high voltage performance. Suggested pad radiuses are shown in Figure 8.

The data are consistent with cost savings by eliminating slots where possible by eliminating solder mask between pads. There is the additional benefit of creating cleaning access if water soluble solder paste is used in board assembly. And finally spreading out field gradients by adding a radius to pads can aid in improving AC breakdown performance. Each layout suggestion needs to be evaluated in new designs as each design will have unknown quirks.

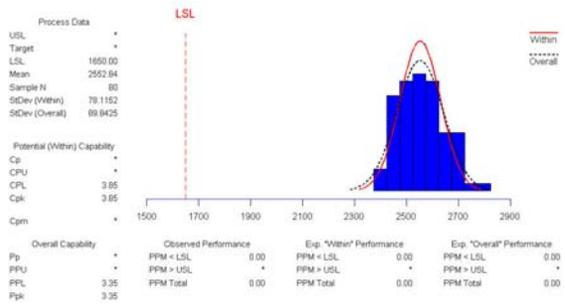
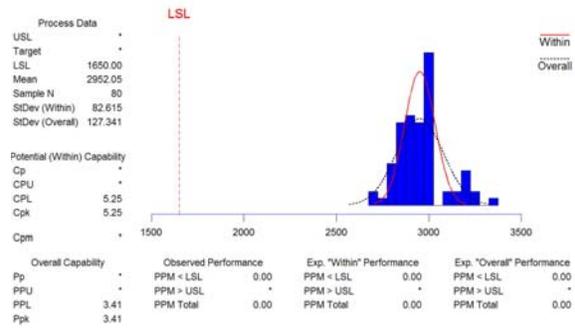
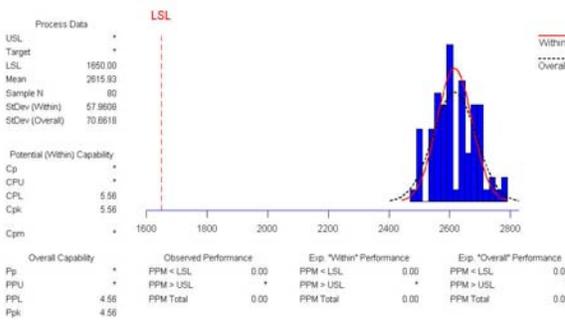
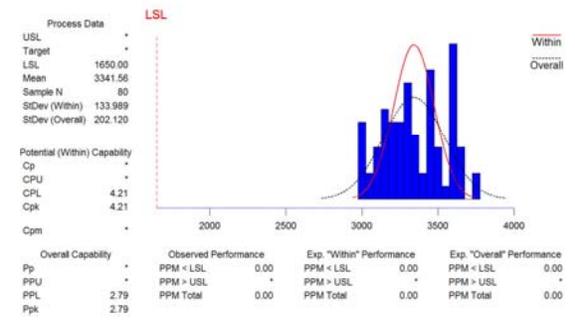
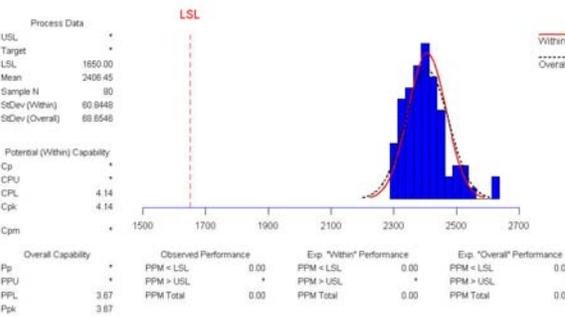
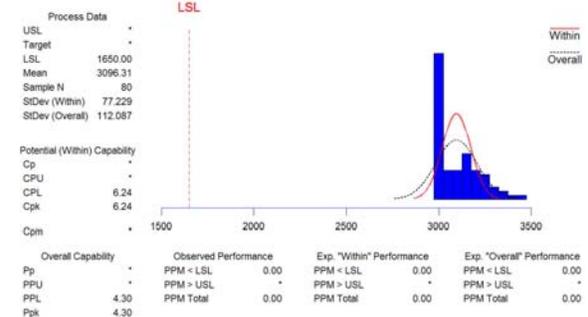
Appendix 1. Bare Board and Sn63 NC Solder Paste AC Breakdown Results

Process Capability Analysis for Solder Mask

Process Capability Analysis for Sn63 NC Solder Mask

Process Capability Analysis for Solder Mask with slot

Process Capability Analysis for Sn63 NC Soldmask w/Slot

Process Capability Analysis for No Solder Mask

Process Capability Analysis for Sn63 NC No Solder Mask

The experimental procedure consisted of exposing both bare boards and assemblies to AC breakdown. A bare board as received was tested for AC breakdown voltage distribution. A second evaluation board had Sn63 No-Clean solder paste stenciled on the pads and reflowed. Those results are listed in Appendix 1 and are used as a baseline for comparisons with capacitors mounted to boards with different fluxes and humidity exposure. What is interesting is that the board AC breakdown capability significantly increased after exposure to reflow soldering temperatures. After components were soldered to the boards and exposed to 48 hours of 85°C/85%RH those breakdown voltages returned to values consistent with the bare board in an as received condition. Real world assemblies will absorb moisture after soldering and depending on where the assemblies are manufactured, stored and the 48 hours of humidity exposure the results inline with the board in its as received condition. The data for the bare board and those with capacitors solder to it is consistent with reflow soldering drying out the assembly.

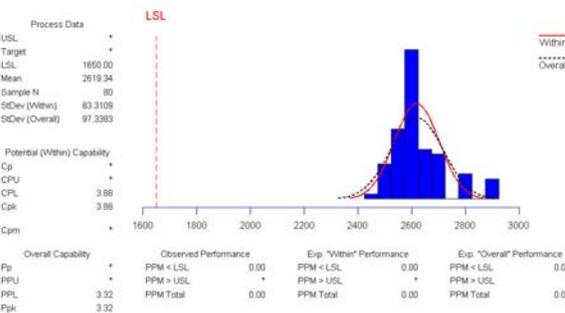
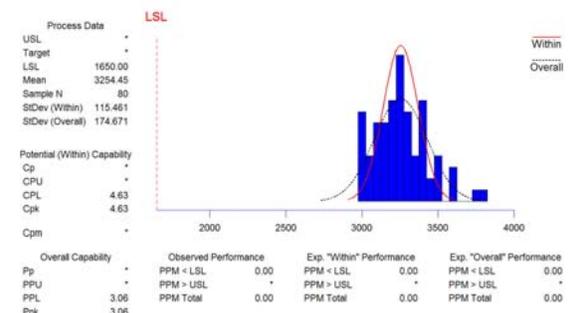
Process Capability Analysis for No Solder Mask with slot

Process Capability Analysis for Sn63 NC No Solder Mask w/Slot
