Table of Contents

5J/52/5221/5223 SERIES.....	P1
5321/5322/5421/5521/5522/5523/5524 SERIES.....	P7
5621/5622/5623/5624 SERIES.....	P13
5631/5632/5918 SERIES.....	P18
5921 SERIES.....	P23
5922/5931/6221/6J31/616PCB SERIES.....	P33

5J SERIES

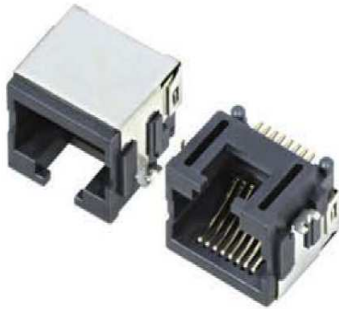
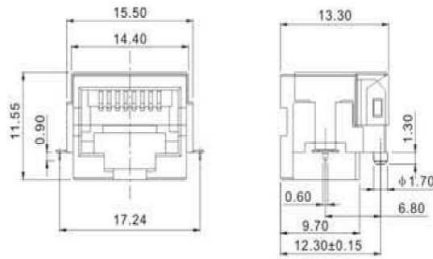
P41000-0XXXX1
5J05-T-SMT-8C

RECOMMENDED P.C.B LAYOUT TOP VIEW
(COMPONENT SIDE TOLERANCE±0.05)

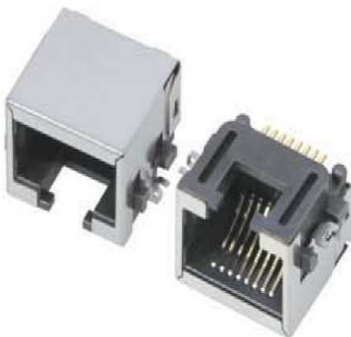
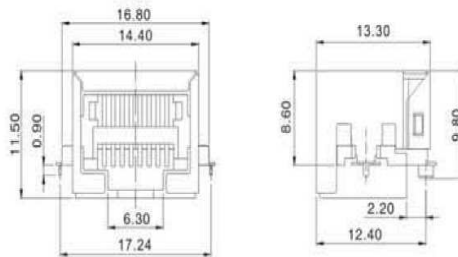
P41028-01XXXX1
5J05-S-SMT-8C-1F

RECOMMENDED P.C.B LAYOUT TOP VIEW
(COMPONENT SIDE TOLERANCE±0.05)

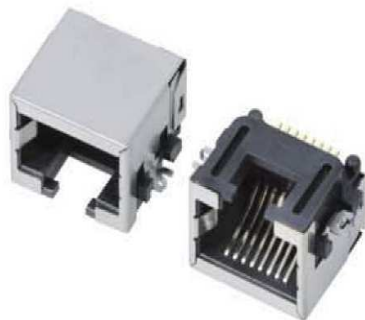
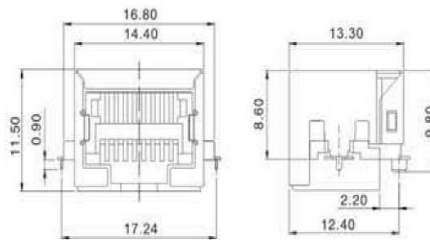
P41028-XXXXX1
5J05-S-SMT-8C-1G

RECOMMENDED P.C.B LAYOUT TOP VIEW
(COMPONENT SIDE TOLERANCE±0.05)

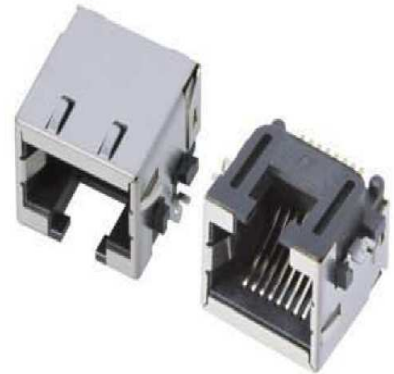
P41330-XXXXX1
5J-S-K4-SMT-8C-1J-G

RECOMMENDED P.C.B LAYOUT TOP VIEW
(COMPONENT SIDE TOLERANCE±0.05)

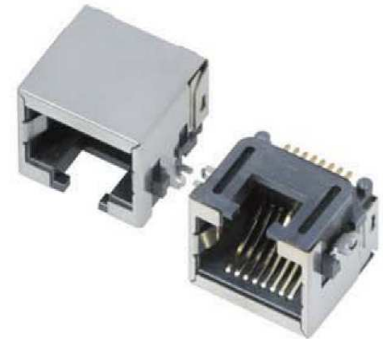
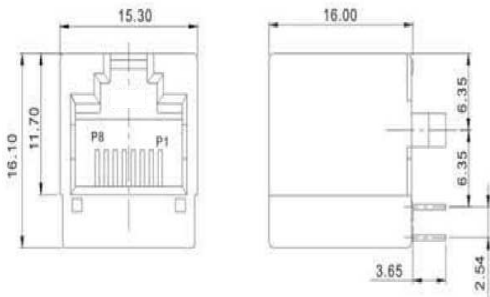
P41332-00J111
5J-S-SMT-8C-1L-G

RECOMMENDED P.C.B LAYOUT TOP VIEW
(COMPONENT SIDE TOLERANCE±0.05)

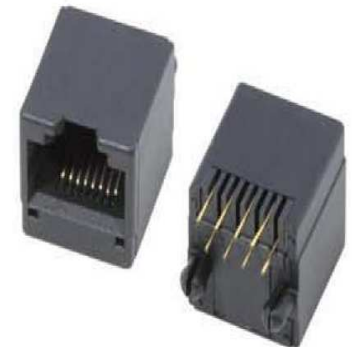
P41350-XXGXX1
52-8C

RECOMMENDED P.C.B LAYOUT TOP VIEW
(COMPONENT SIDE TOLERANCE±0.05)

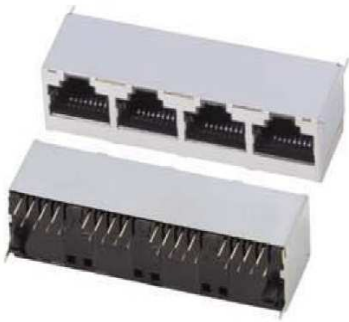
P41351-XXGXX1
52-S-D-8C(4C)

RECOMMENDED P.C.B LAYOUT TOP VIEW
(COMPONENT SIDE TOLERANCE±0.05)

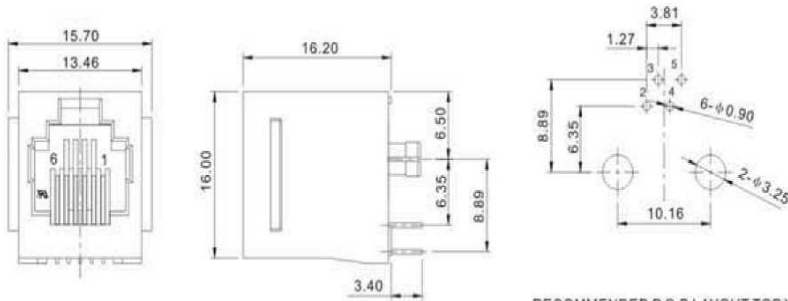
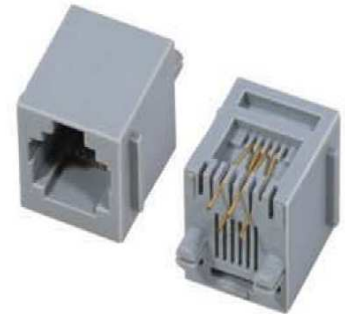
P11080-XXGXXX
5221-1R-W-6P4C (6C/2C)

RECOMMENDED P.C.B LAYOUT TOP VIEW
(COMPONENT SIDE TOLERANCE±0.05)

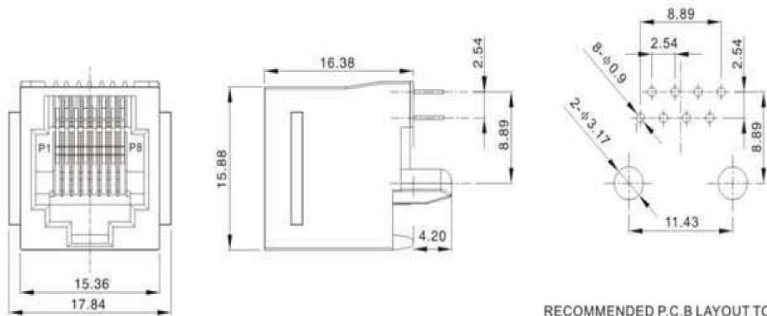
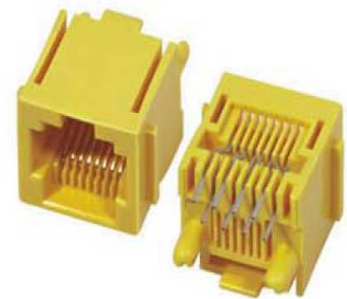
P41001-XXXXXX
5223-Q-R-8P8C

RECOMMENDED P.C.B LAYOUT TOP VIEW
(COMPONENT SIDE TOLERANCE±0.05)

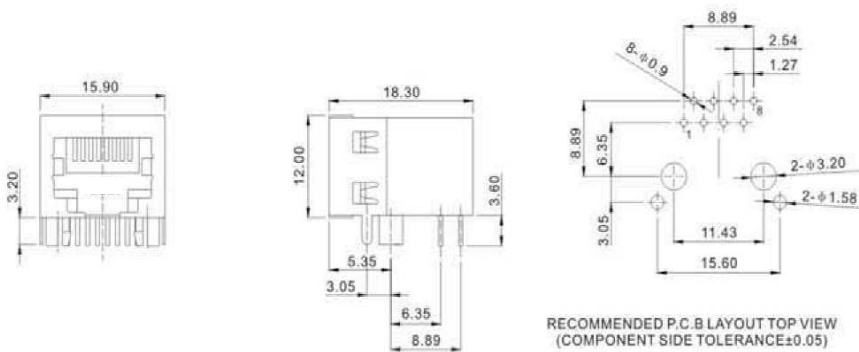
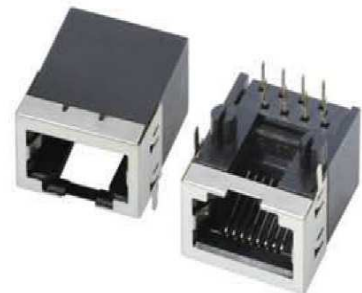
P41038-00GXX1
5221-T-D-8C(4C)

RECOMMENDED P.C.B LAYOUT TOP VIEW
(COMPONENT SIDE TOLERANCE±0.05)

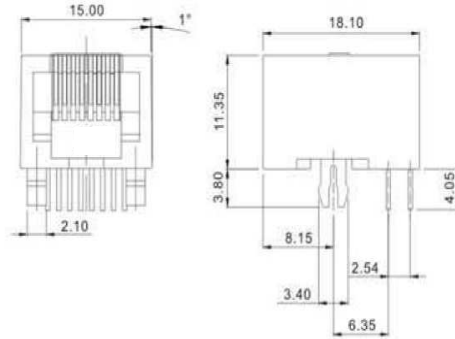
P41040-00GXX1
5321-1-W-8C(4C)

RECOMMENDED P.C.B LAYOUT TOP VIEW
(COMPONENT SIDE TOLERANCE±0.05)

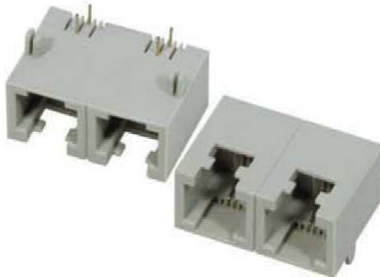
P11024-XXXXX1
5321-2-6P2C (6C/4C)

RECOMMENDED P.C.B LAYOUT TOP VIEW
(COMPONENT SIDE TOLERANCE±0.05)

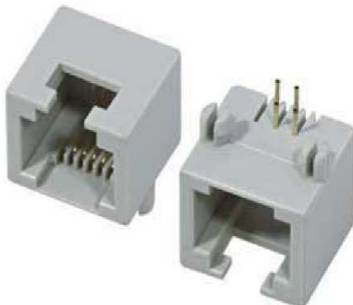
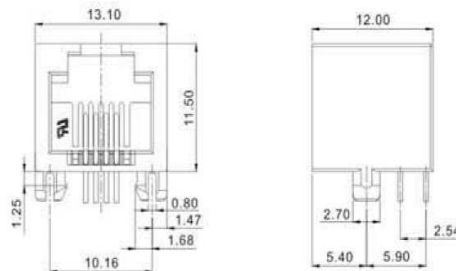
P11002-XXGXX1
5321-1-6P4C (6C/2C)

RECOMMENDED P.C.B LAYOUT TOP VIEW
(COMPONENT SIDE TOLERANCE±0.05)

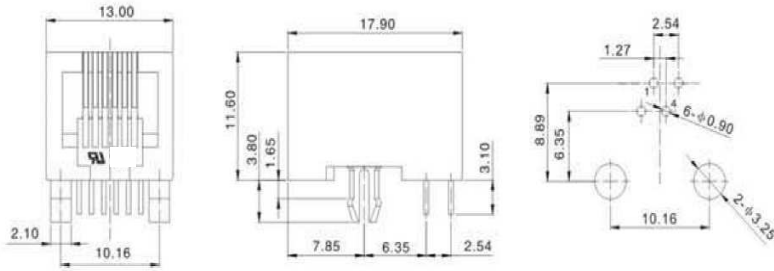
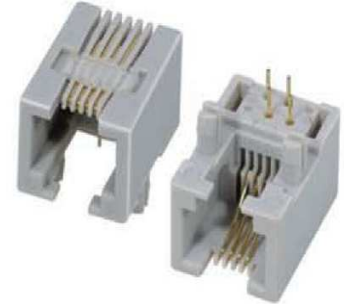
P11005-00GXX1
5321-1-W-6P4C(6C/2C)

RECOMMENDED P.C.B LAYOUT TOP VIEW
(COMPONENT SIDE TOLERANCE±0.05)

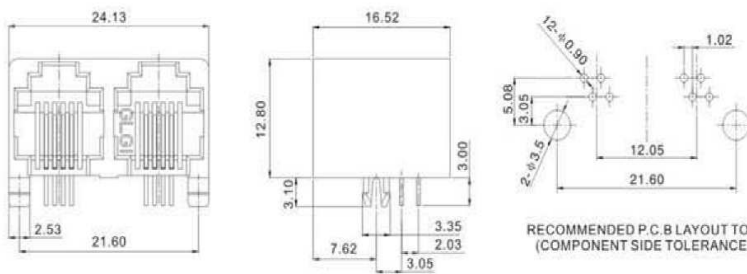
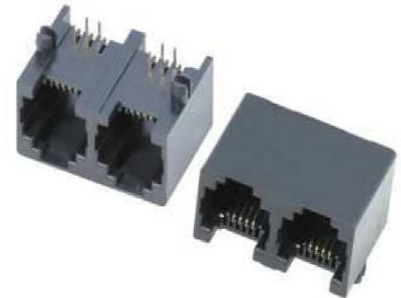
P11040-00GXX1
5322-2-6P4C(6C/2C)

RECOMMENDED P.C.B LAYOUT TOP VIEW
(COMPONENT SIDE TOLERANCE±0.05)

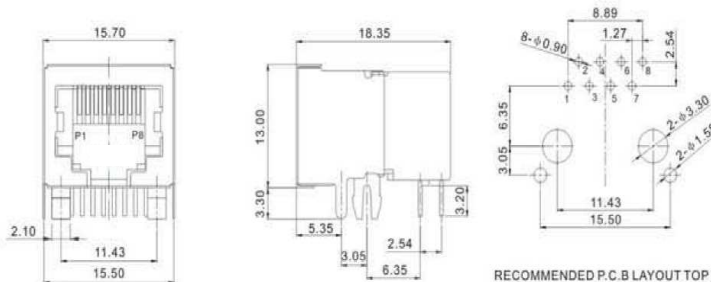
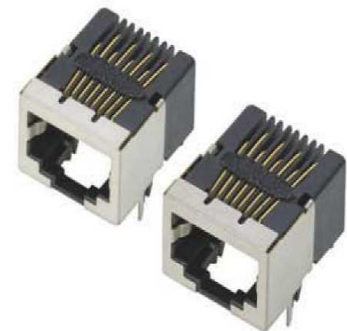
P41380-00GXX1
5421-T-D-W-8C(4C)

RECOMMENDED P.C.B LAYOUT TOP VIEW
(COMPONENT SIDE TOLERANCE±0.05)

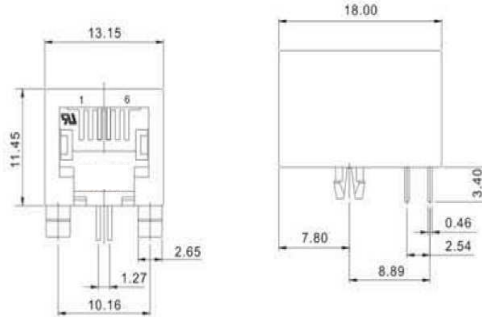
P11056-00GXX1
5523-1-6P2C(6C/4C)

RECOMMENDED P.C.B LAYOUT TOP VIEW
(COMPONENT SIDE TOLERANCE±0.05)

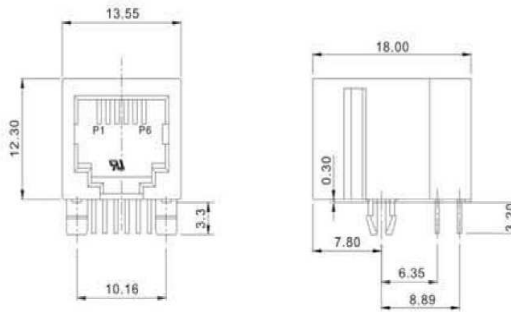
P11111-00GXX1
5524-6P6C(4C/2C)

RECOMMENDED P.C.B LAYOUT TOP VIEW
(COMPONENT SIDE TOLERANCE±0.05)

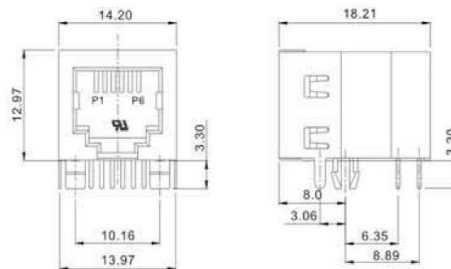
P11112-00GXX1
5524-T-D-6P6C (4C/2C)

RECOMMENDED P.C.B LAYOUT TOP VIEW
(COMPONENT SIDE TOLERANCE±0.05)

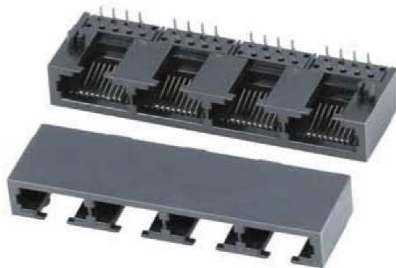
P41018-XXGXX1
5622-1X4-8C(4C)

RECOMMENDED P.C.B LAYOUT TOP VIEW
(COMPONENT SIDE TOLERANCE±0.05)

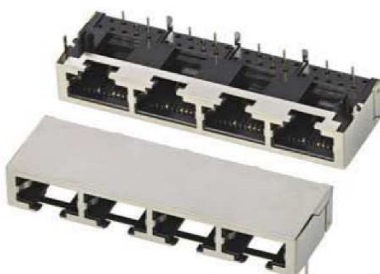
P41021-XXGXX1
5622-S-D-1X4-4C-III (BK3/8C)

RECOMMENDED P.C.B LAYOUT TOP VIEW
(COMPONENT SIDE TOLERANCE±0.05)

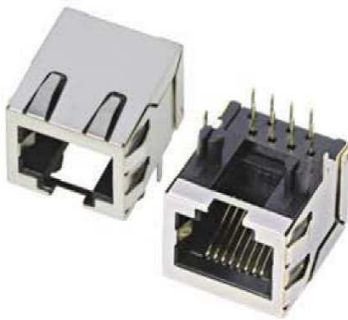
P41014-00GXX1
5622-S-K6-C-8C(4C)

RECOMMENDED P.C.B LAYOUT TOP VIEW
(COMPONENT SIDE TOLERANCE±0.05)

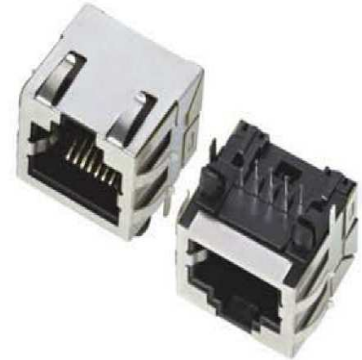
P41227-XXXXX1
5631-Q-S-K6-F-8C

RECOMMENDED P.C.B LAYOUT TOP VIEW
(COMPONENT SIDE TOLERANCE±0.05)

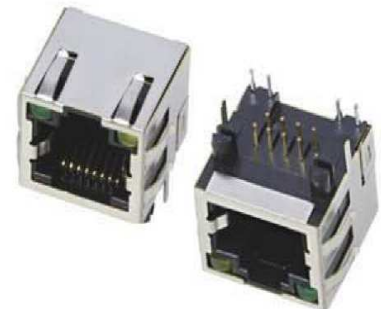
P42022-XXGXX1
5631-S-K6-F-L-8C

RECOMMENDED P.C.B LAYOUT TOP VIEW
(COMPONENT SIDE TOLERANCE±0.05)

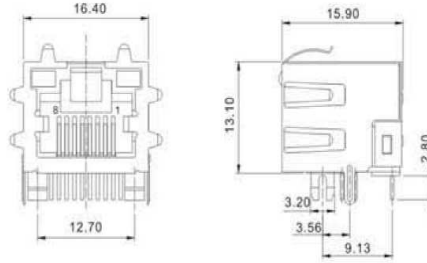
P42002-XXXXX1
5631-Q-S-K6-F-L-8C

RECOMMENDED P.C.B LAYOUT TOP VIEW
(COMPONENT SIDE TOLERANCE±0.05)

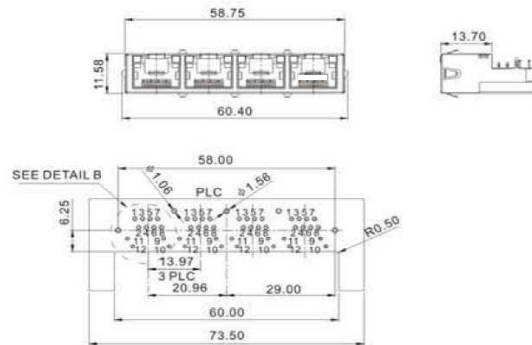
P42001-0001
5918-Q-S-K8-1X4-8P8C

RECOMMENDED P.C.B LAYOUT TOP VIEW
(COMPONENT SIDE TOLERANCE±0.05)

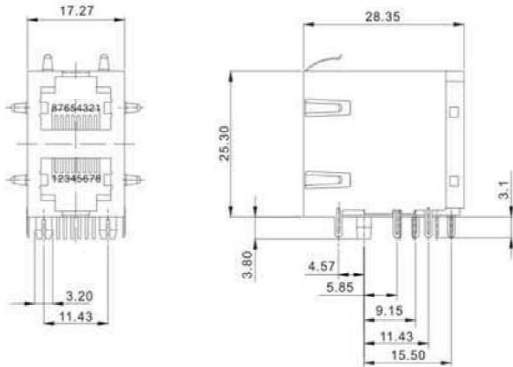
P43001-XXGXX1
5921-S-K6-A-2X1-8C(4C)

RECOMMENDED P.C.B LAYOUT TOP VIEW
(COMPONENT SIDE TOLERANCE±0.05)

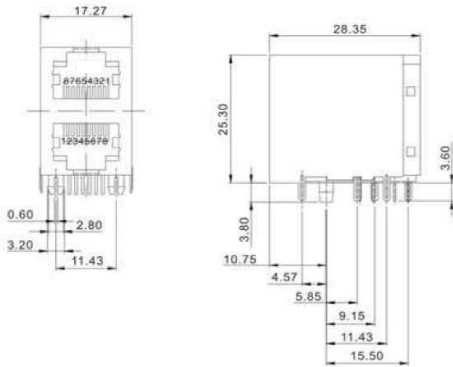
P43003-00XXX1
5921-Q-S-A-2X1-8C

RECOMMENDED P.C.B LAYOUT TOP VIEW
(COMPONENT SIDE TOLERANCE±0.05)

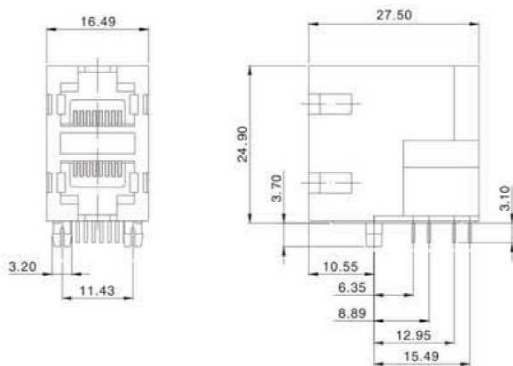
P43005-00GXX1
5921-2X1-8C

RECOMMENDED P.C.B LAYOUT TOP VIEW
(COMPONENT SIDE TOLERANCE±0.05)

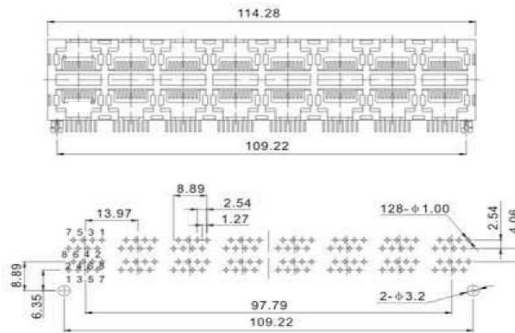
P43060-XXGXX1
5921-2X8-8C-1A

RECOMMENDED P.C.B LAYOUT TOP VIEW
(COMPONENT SIDE TOLERANCE±0.05)

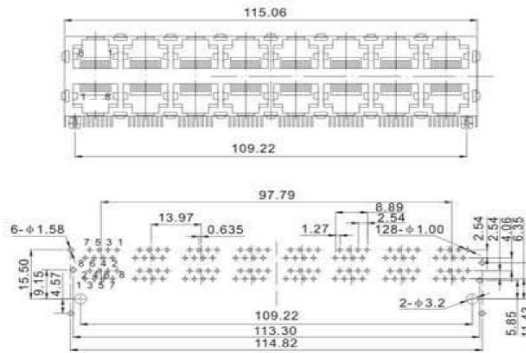
P43062-XXGXX1
5921-S-FK18-A-2X8-8C

RECOMMENDED P.C.B LAYOUT TOP VIEW
(COMPONENT SIDE TOLERANCE±0.05)

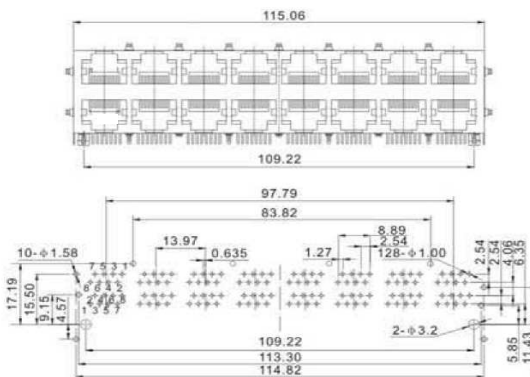
P43065-00XXX1
5921-Q-S-K18-A-2X8-8C-IV

RECOMMENDED P.C.B LAYOUT TOP VIEW
(COMPONENT SIDE TOLERANCE±0.05)

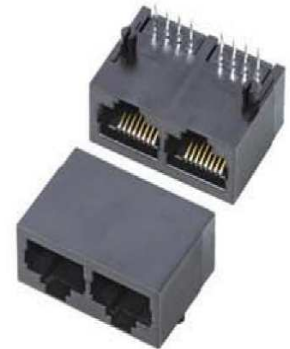
P41089-00XXX1
5921-Q-1X2-8C

RECOMMENDED P.C.B LAYOUT TOP VIEW
(COMPONENT SIDE TOLERANCE±0.05)

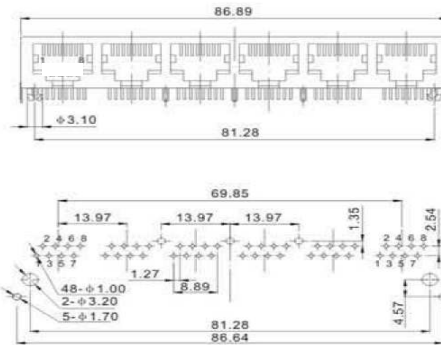
P41132-XXGXX1
5921-S-A-1X6-8C(4C)-III

RECOMMENDED P.C.B LAYOUT TOP VIEW
(COMPONENT SIDE TOLERANCE±0.05)

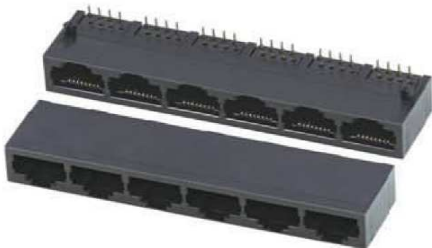
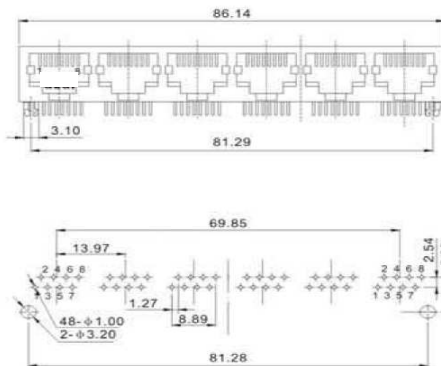
P4113-00GXX1
5921-1X6-8C(4C)

RECOMMENDED P.C.B LAYOUT TOP VIEW
(COMPONENT SIDE TOLERANCE±0.05)

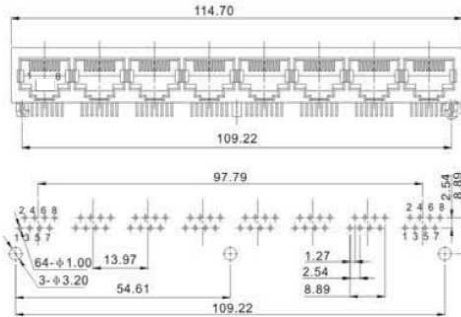
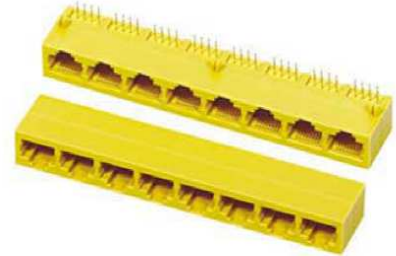
P41095-XXGXX1
5921-1X8-C-8C(4C)

RECOMMENDED P.C.B LAYOUT TOP VIEW
(COMPONENT SIDE TOLERANCE±0.05)

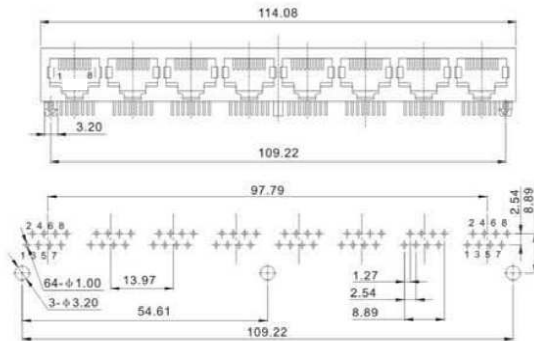
P41097-XXGXX1
5921-1X8-8C-(4C)

RECOMMENDED P.C.B LAYOUT TOP VIEW
(COMPONENT SIDE TOLERANCE±0.05)

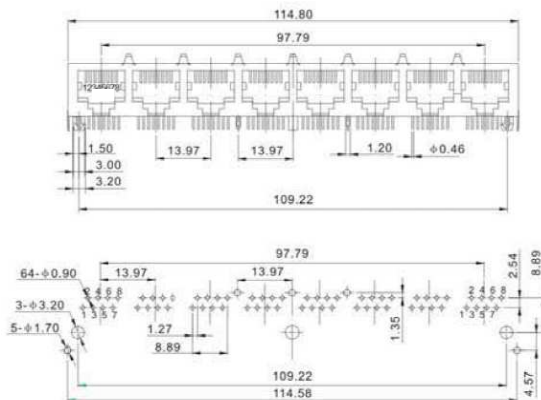
P41102-XXGXX1
5921-S-BK7-A-1X8-8C-III

RECOMMENDED P.C.B LAYOUT TOP VIEW
(COMPONENT SIDE TOLERANCE±0.05)

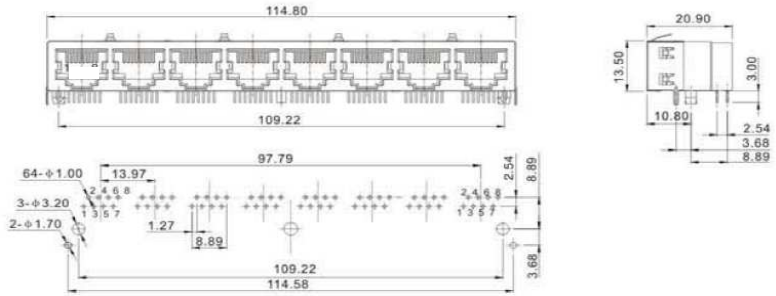
P41105-XXGXX1
5921-T-BK4-B-1X8-8C(4C)

RECOMMENDED P.C.B LAYOUT TOP VIEW
(COMPONENT SIDE TOLERANCE±0.05)

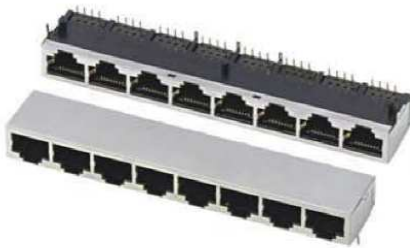
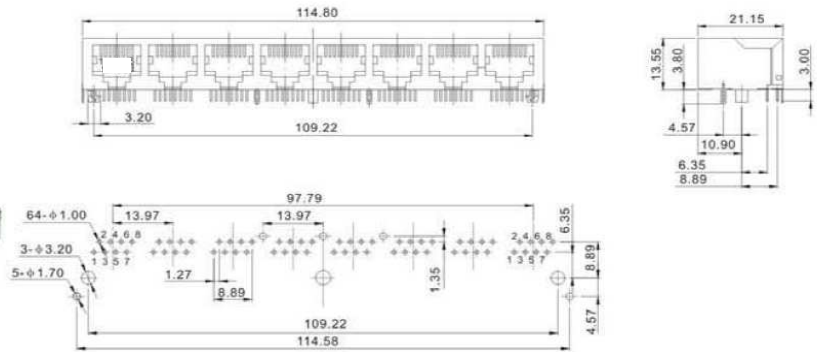
P41111-00SXX1
5921-Q-S-A-1X8-8C-III

RECOMMENDED P.C.B LAYOUT TOP VIEW
(COMPONENT SIDE TOLERANCE±0.05)

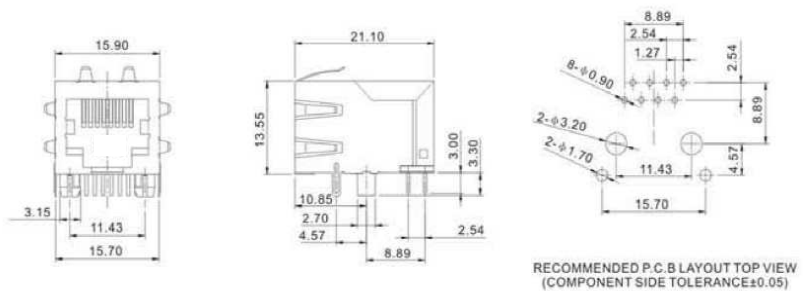
P41108-XXGXX1
5921-S-K6-A-8C(4C)-G

RECOMMENDED P.C.B LAYOUT TOP VIEW
(COMPONENT SIDE TOLERANCE±0.05)

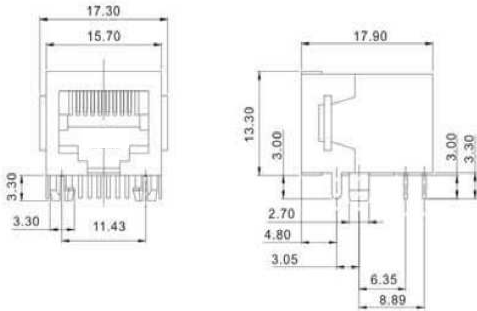
P41052-XXGXX1
5921-T-D-R-10P8C(4C)-1C

RECOMMENDED P.C.B LAYOUT TOP VIEW
(COMPONENT SIDE TOLERANCE±0.05)

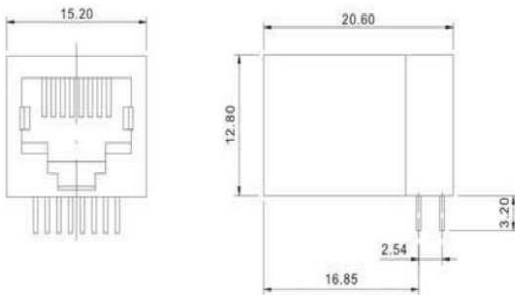
P41054-XXGXX1
5921-8P8C(4C)

RECOMMENDED P.C.B LAYOUT TOP VIEW
(COMPONENT SIDE TOLERANCE±0.05)

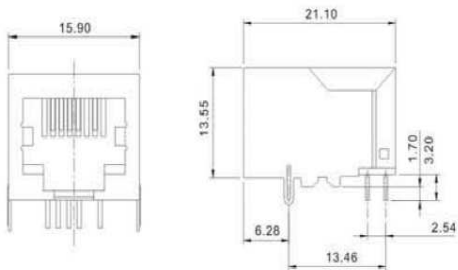
P41056-XXGXX1
5921-S-A-8P5C-2A

RECOMMENDED P.C.B LAYOUT TOP VIEW
(COMPONENT SIDE TOLERANCE±0.05)

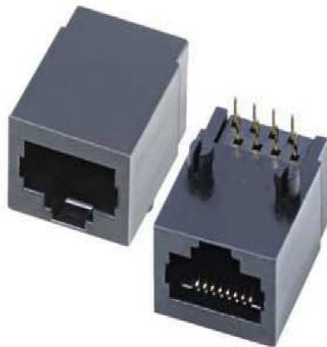
P41094-00GXX1
5921-C-8P8C-1B

RECOMMENDED P.C.B LAYOUT TOP VIEW
(COMPONENT SIDE TOLERANCE±0.05)

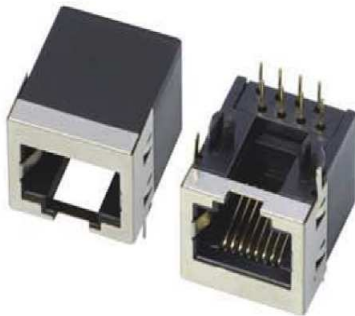
P41370-XXGXX1
5922-T-A-8C

RECOMMENDED P.C.B LAYOUT TOP VIEW
(COMPONENT SIDE TOLERANCE±0.05)

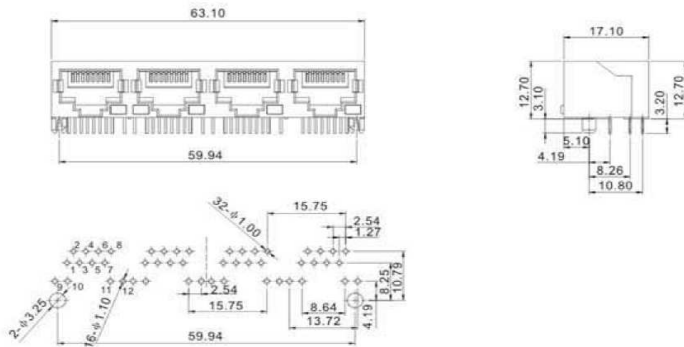
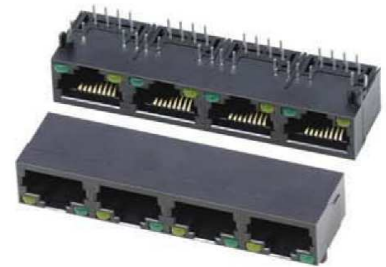
P42100-XXXXX1
5931-Q-1X4-L-8C

RECOMMENDED P.C.B LAYOUT TOP VIEW
(COMPONENT SIDE TOLERANCE±0.05)

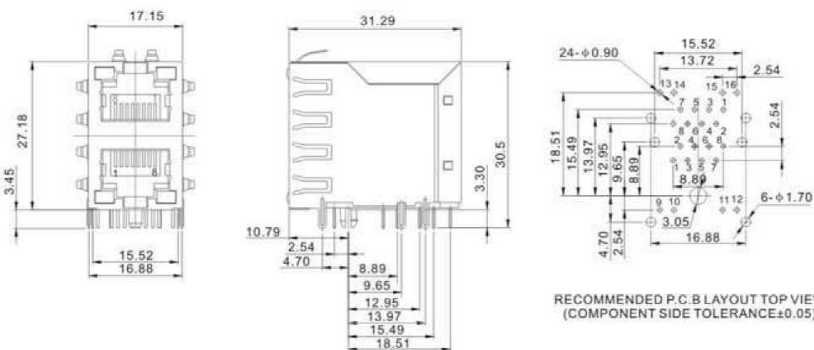
P45003-XXXXX1
5931-Q-S-K10-2X1-L-C-8C(JK4)

RECOMMENDED P.C.B LAYOUT TOP VIEW
(COMPONENT SIDE TOLERANCE±0.05)

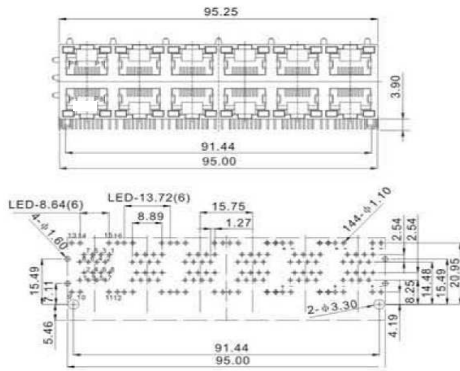
P45046-00XXX1
5931-Q-S-BK10-2X6-L-a-8C

RECOMMENDED P.C.B LAYOUT TOP VIEW
(COMPONENT SIDE TOLERANCE±0.05)

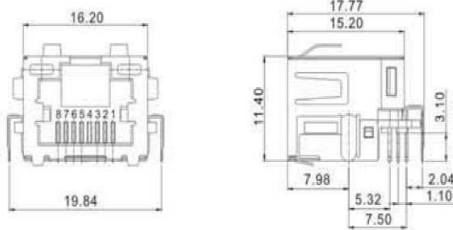
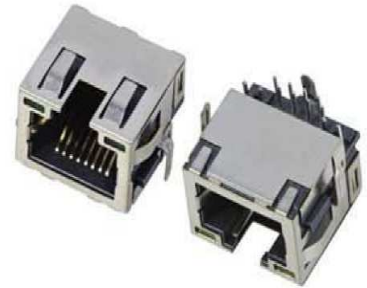
P42000-XXXXX1
6221-Q-S-K6-L-8C(OG/G)

RECOMMENDED P.C.B LAYOUT TOP VIEW
(COMPONENT SIDE TOLERANCE±0.05)

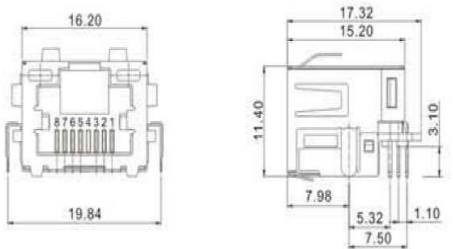
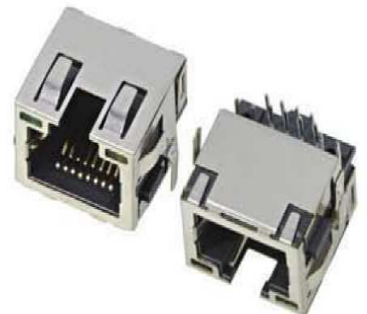
P42003-XXXXX1
6221-Q-S-K6-L-8C(G/Y)

RECOMMENDED P.C.B LAYOUT TOP VIEW
(COMPONENT SIDE TOLERANCE±0.05)

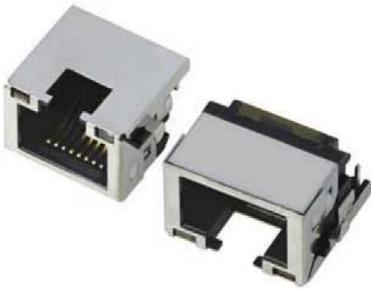
P41911-00S092
6J31-Q-S-L-8P8C

RECOMMENDED P.C.B LAYOUT TOP VIEW
(COMPONENT SIDE TOLERANCE±0.05)

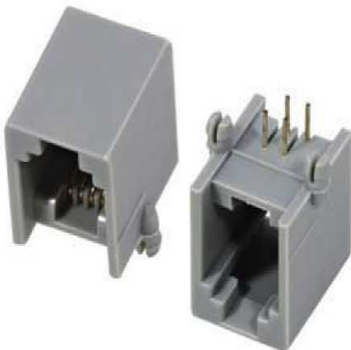
P11061-XXGXX1
616PCB-4P4C(2C)

RECOMMENDED P.C.B LAYOUT TOP VIEW
(COMPONENT SIDE TOLERANCE±0.05)
